Asbestos Re-inspection  
& Management Plan  
for:

**36/38 Friars Walk  
Lewes  
East Sussex  
BN7 2PB**

**Sussex Community NHS Foundation Trust  
Brighton General Hospital  
Elm Grove  
Brighton  
BN2 3E**

**DATE:** 21/10/19  
**REFERENCE:** 2019 - 392  
**SURVEYOR:** T. HASTINGS (BSC. ENV. PGDIP. AMIOA)

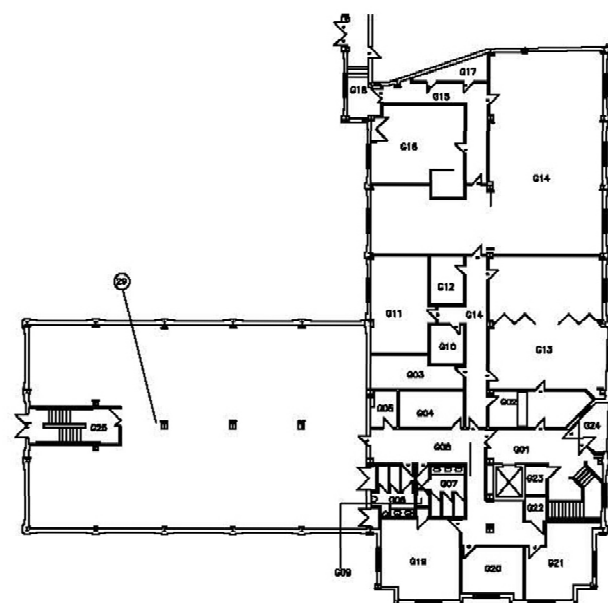
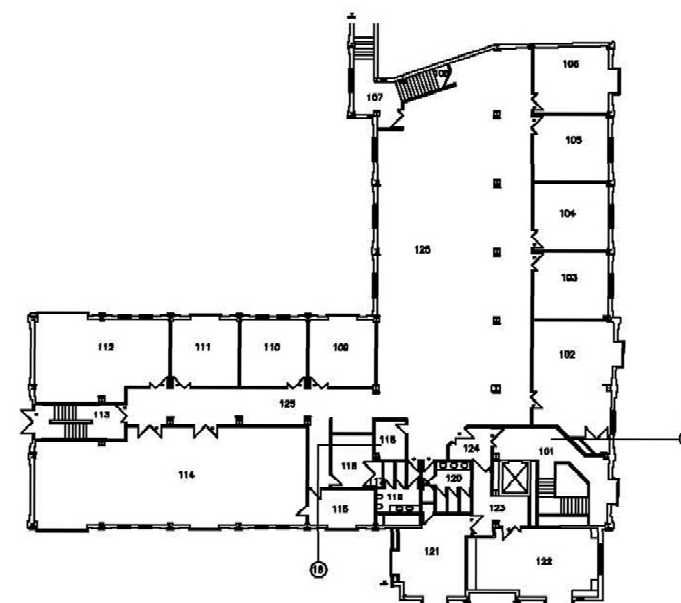
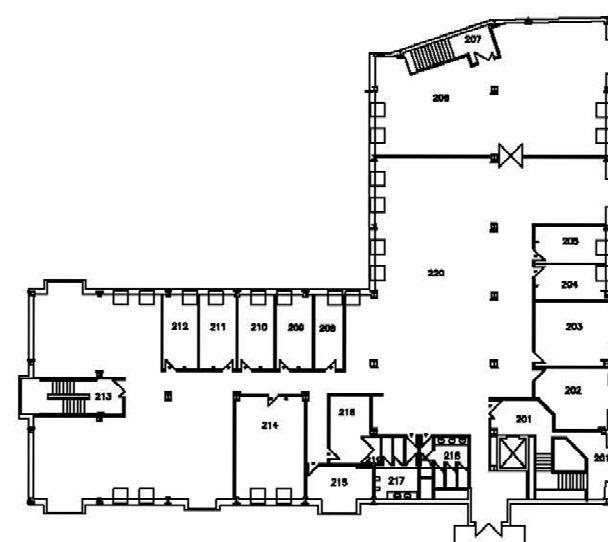
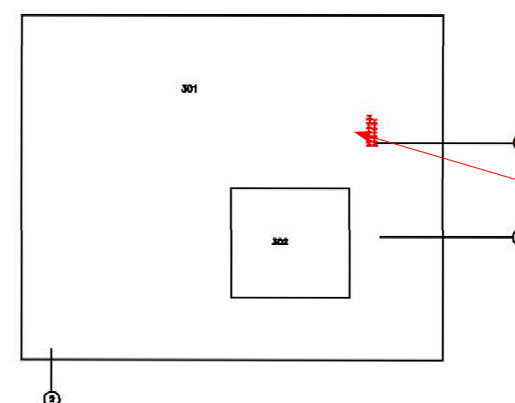
Asbestos gaskets to pipe  
flanges in plant room  
(strongly presumed)

Ref	Priority Category	Re-inspection frequency	Notes/ Clearance Cert No.	Detailed Actions	By When	By Whom	Date last inspected completed
ASB21	D	730		Manage and Monitor Safe Condition	20/10/2021	Sussex Community NHS Trust	21/10/2019

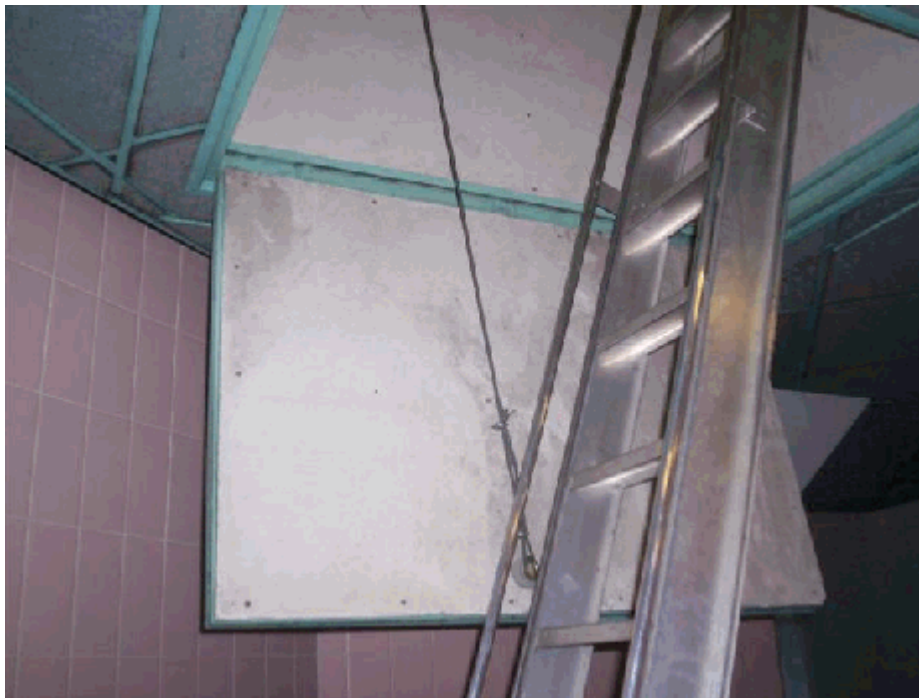
**Description:** Insulating board Panels to back of hatch, surround to hatch & debris (supalux)

**Damage:** 3 - High

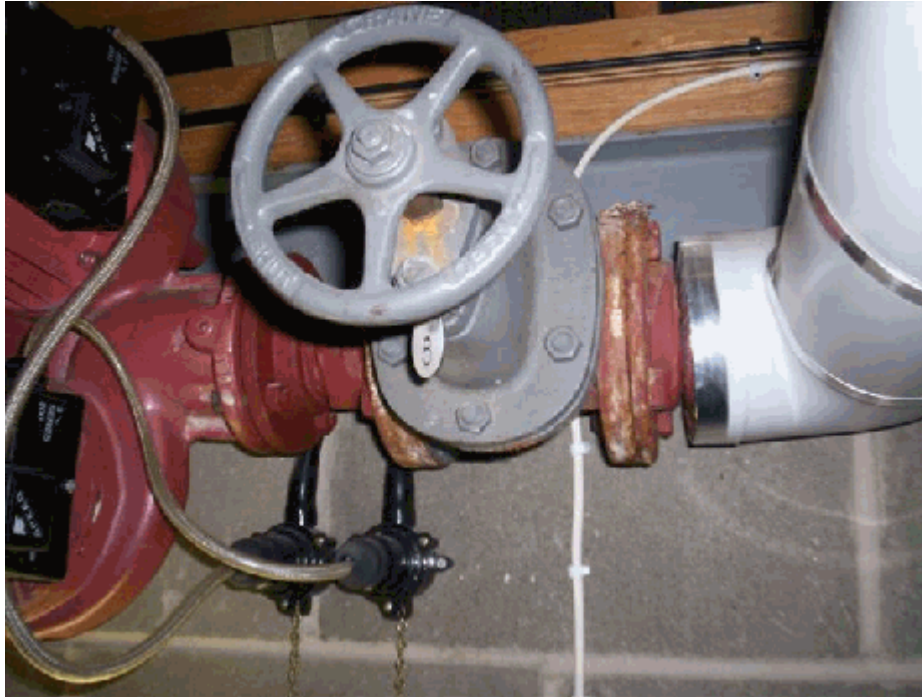
**Description:** Gaskets to x13 pipe flanges

**Damage:** 1 - Low

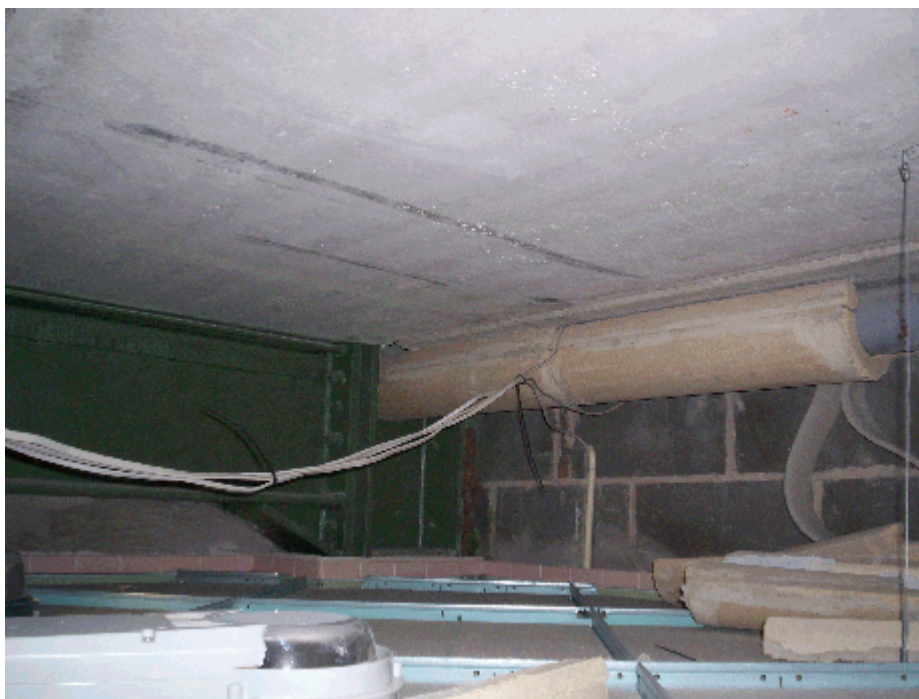
**Description:** Vermiculite beam cladding & loose debris

**Damage:** 3 - High

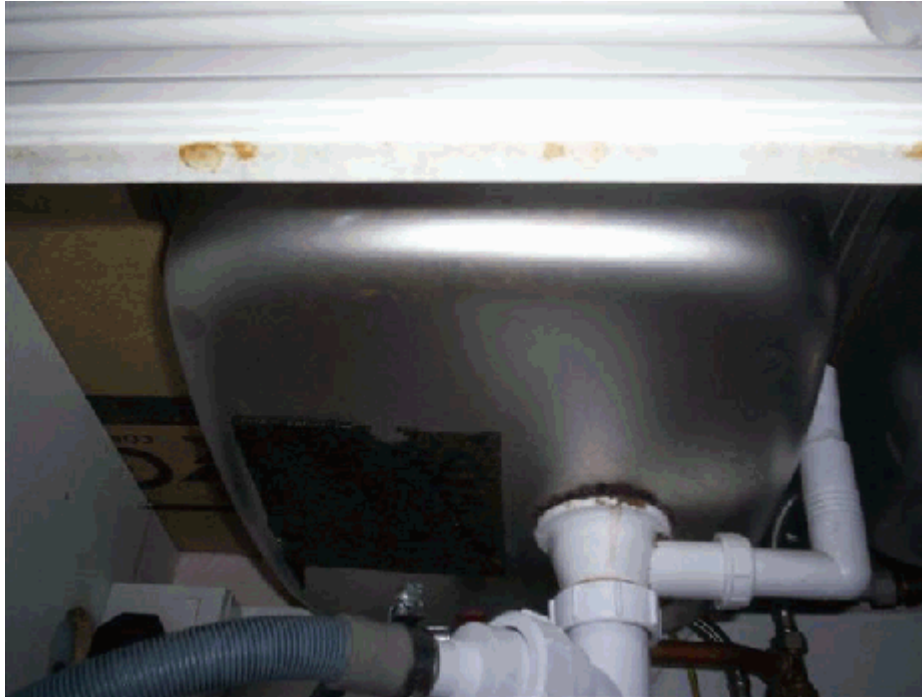
**Description:** Sink pad & debris

**Damage:** 2 - Medium

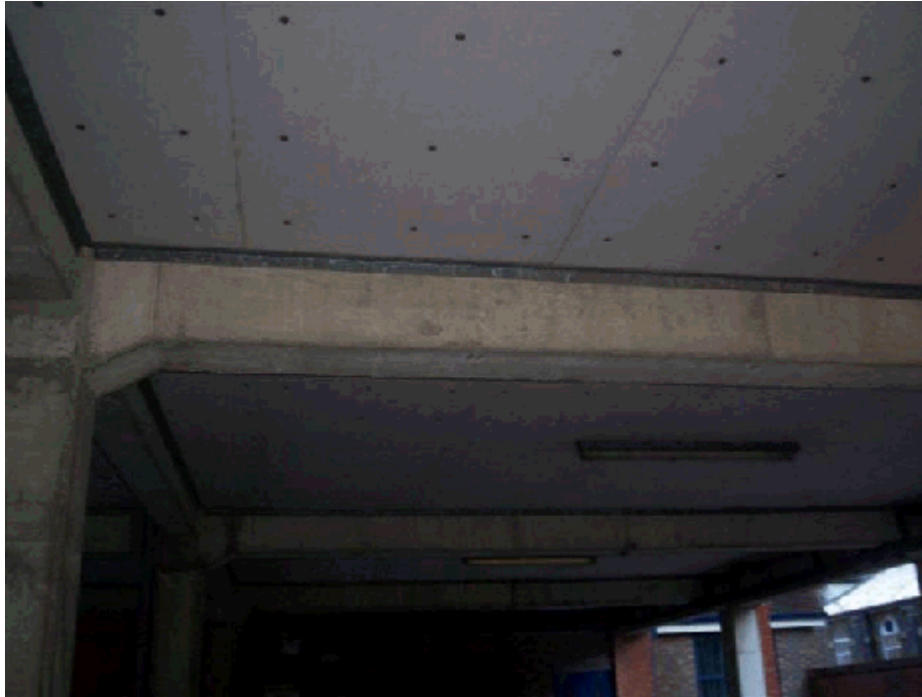
**Description:** Insulating board ceiling panels above car park

**Damage:** 0 - None

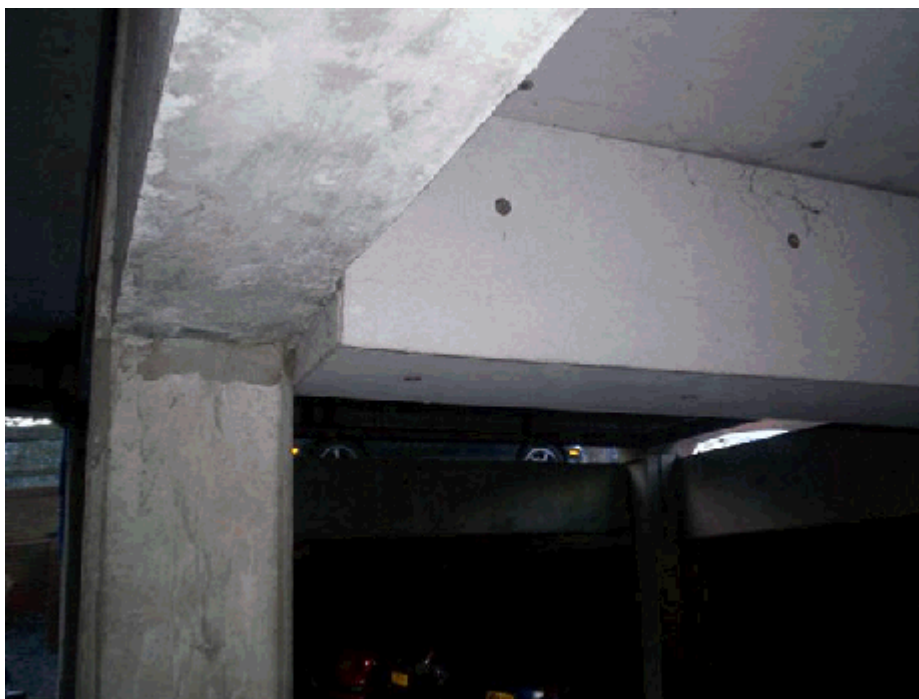
**Description:** Insulating board cladding to beams to car park area

**Damage:** 1 - Low
