**AMSTECH** CONTRACTS LIMITED

**A MANAGEMENT SURVEY TO LOCATE AND  
IDENTIFY  
ASBESTOS BEARING MATERIALS  
At  
ST JOHN'S SCHOOL  
FIRLE ROAD  
SEAFORD  
EAST SUSSEX  
BN25 2HU**

**Survey Report No. CS8991E**

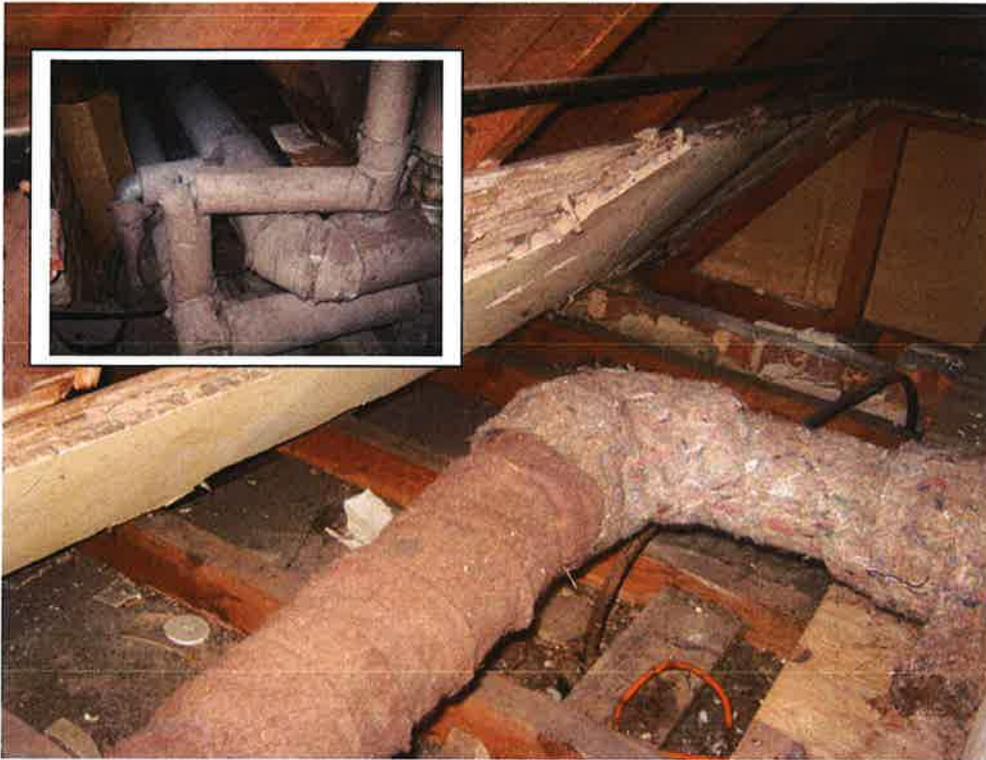
Sample No:	No sample	Picture 1
Survey Date:	12 <sup>th</sup> September 2012	
Location:	Second floor	
Position:	Roof void	
Component:	Hessian & Aconite pipe insulation	
Condition/ Protection:	-	
Accessibility:	-	
Analysis result:	-	
Risk Code:	-	
Recommended Action:	No asbestos materials suspected

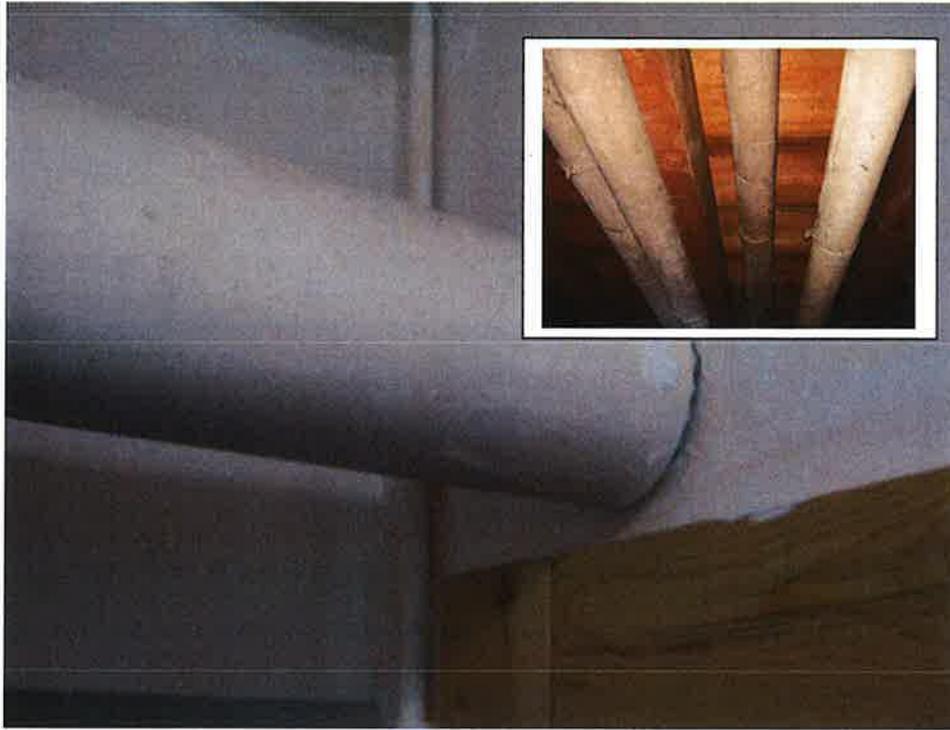
Sample No:	No sample	Picture 2
Survey Date:	12 <sup>th</sup> September 2012	
Location:	Second floor	
Position:	To pipe runs	
Component:	MMM & Aconite pipe insulation	
Condition/ Protection:	-	
Accessibility:	-	
Analysis result:	-	
Risk Code:	-	
Recommended Action:	No asbestos materials suspected

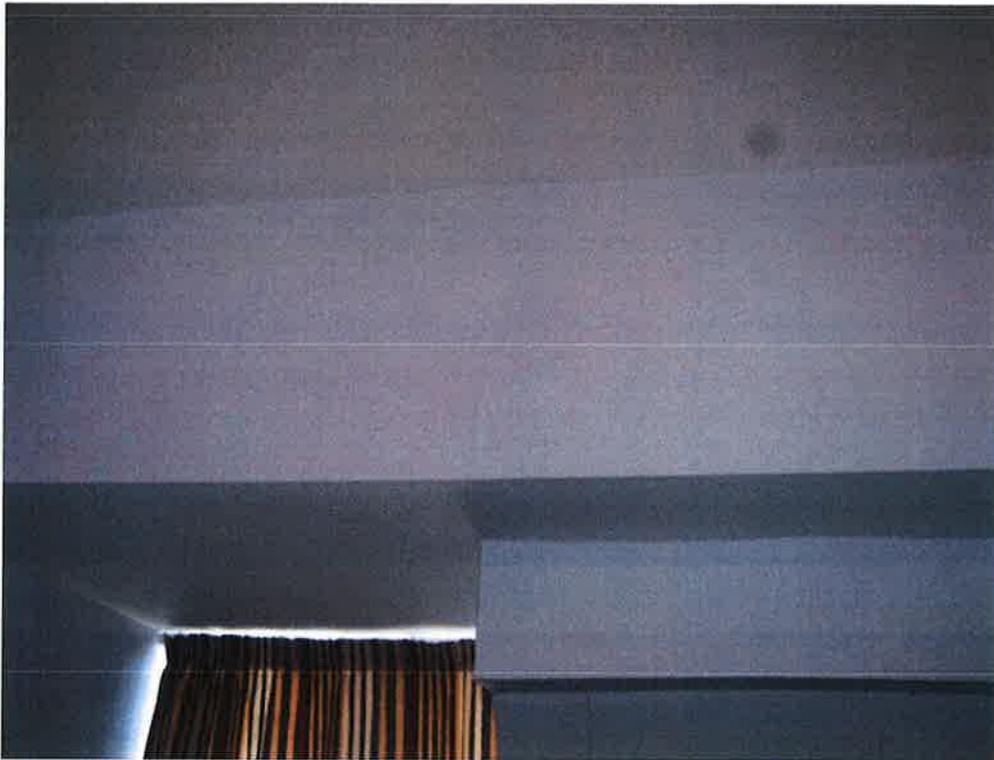
Sample No:	No sample	Picture 3
Survey Date:	12 <sup>th</sup> September 2012	
Location:	Second floor	
Position:	Walls/ceilings	
Component:	Solid and plaster rendered/original lathe and plaster/plaster board panels	
Condition/ Protection:	-	
Accessibility:	-	
Analysis result:	-	
Risk Code:	-	
Recommended Action:	No asbestos materials suspected

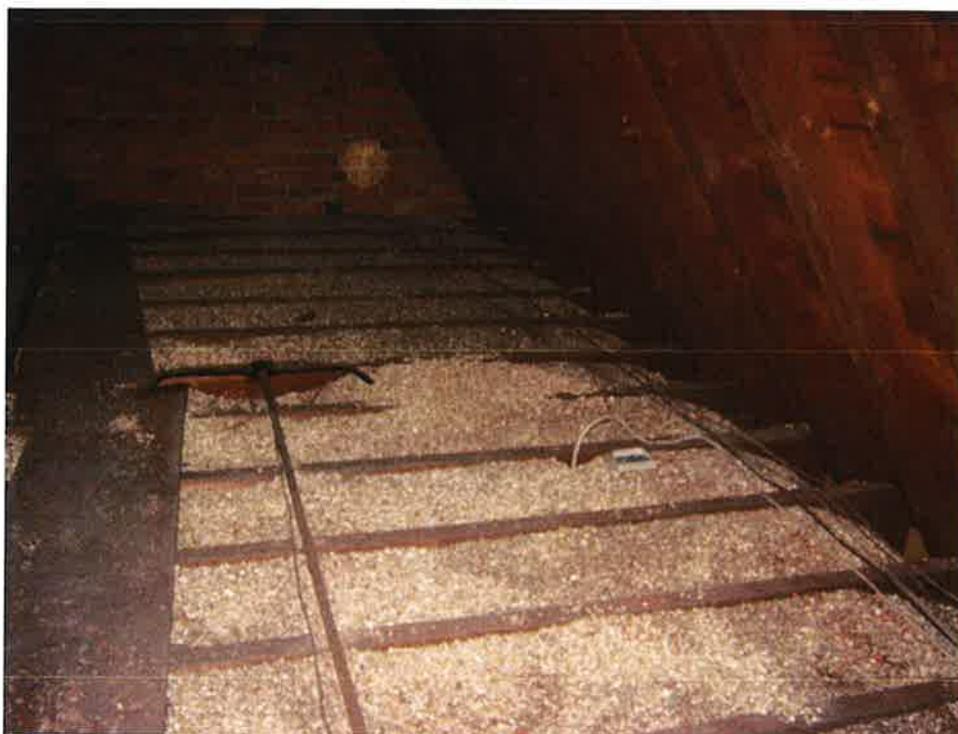
Sample No:	No sample	Picture 4
Survey Date:	12 <sup>th</sup> September 2012	
Location:	Second floor	
Position:	Roof voids	
Component:	Loose fill Vermiculite insulation	
Condition/ Protection:	-	
Accessibility:	-	
Analysis result:	-	
Risk Code:	-	
Recommended Action:	No asbestos materials suspected

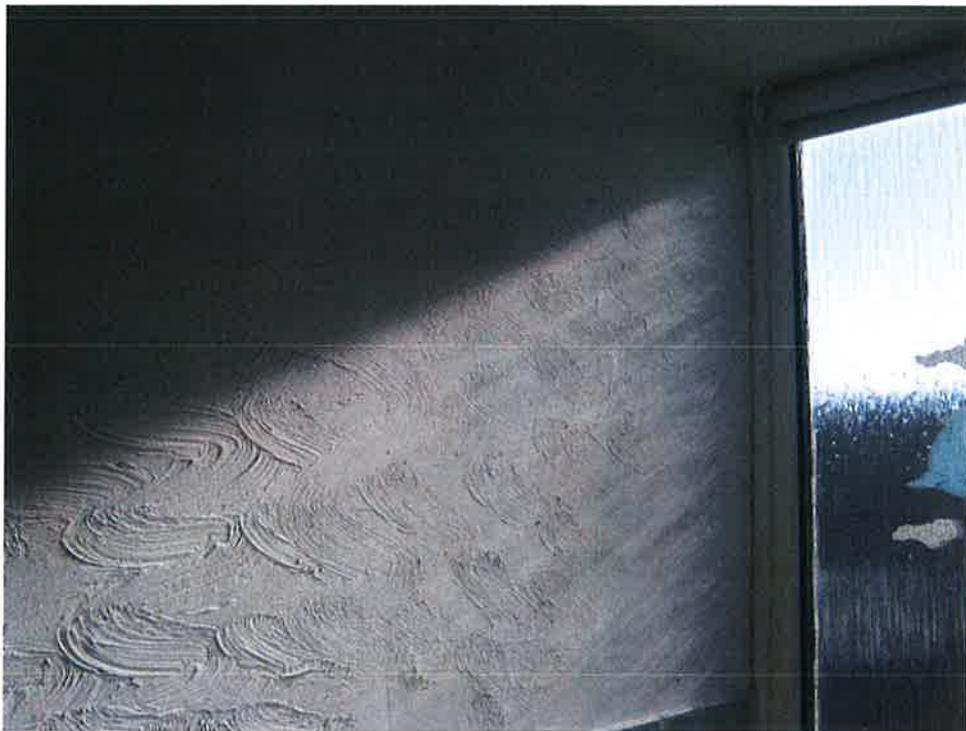
Sample No:	Sample 1-CS8991E/1	Picture 5
Survey Date:	12 <sup>th</sup> September 2012	
Location:	Second floor	
Position:	Bathroom wall	
Component:	Textured coating	
Condition/ Protection:	-	
Accessibility:	-	
Analysis result:	<b>No asbestos detected</b>	
Risk Code:	-	
Recommended Action:	None

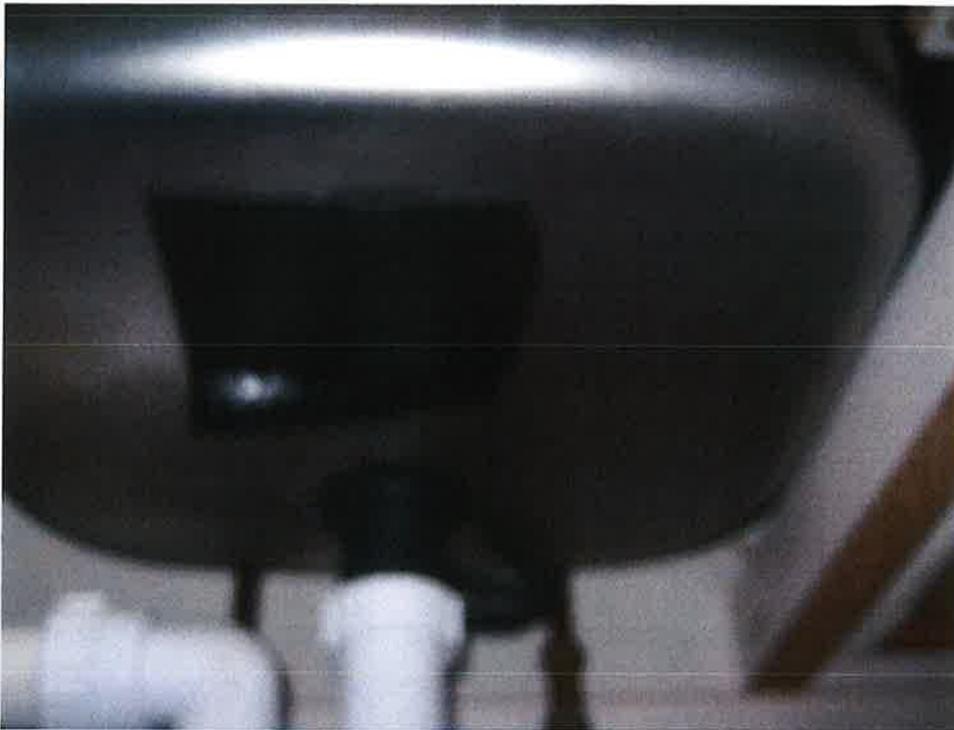
- 3.6 The bitumen material acoustic sink pad was sampled from beneath the domestic sink unit within the second floor kitchen and following analysis the material was found to be non-asbestos. **Sample 2-CS8991E/2 Picture 6**  
Note: Identical sink pads were observed in various locations throughout the building and can also be assumed to be non-asbestos.

Sample No:	Sample 2-CS8991E/2	Picture 6
Survey Date:	12 <sup>th</sup> September 2012	
Location:	Second floor	
Position:	Kitchen sink unit	
Component:	Bitumen acoustic sink unit	
Condition/ Protection:	-	
Accessibility:	-	
Analysis result:	<b>No asbestos detected</b>	
Risk Code:	-	
Recommended Action:	None

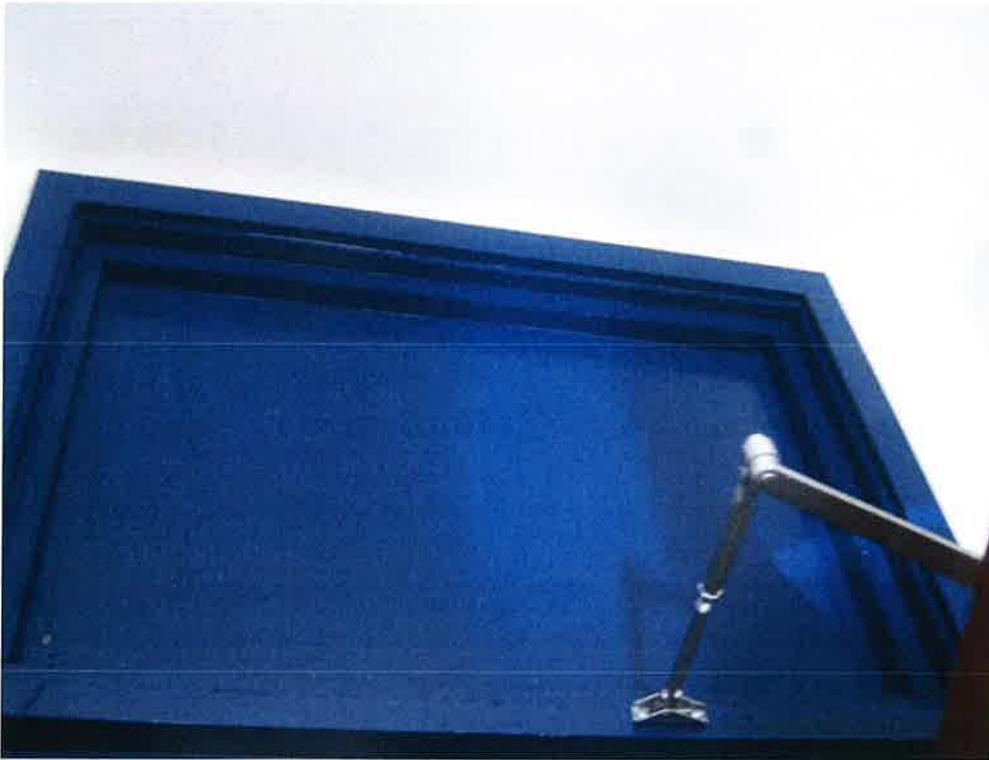
Sample No:	No sample	Picture 7
Survey Date:	12 <sup>th</sup> September 2012	
Location:	Second floor	
Position:	Door heads	
Component:	Timber panels	
Condition/ Protection:	-	
Accessibility:	-	
Analysis result:	-	
Risk Code:	-	
Recommended Action:	No asbestos materials suspected

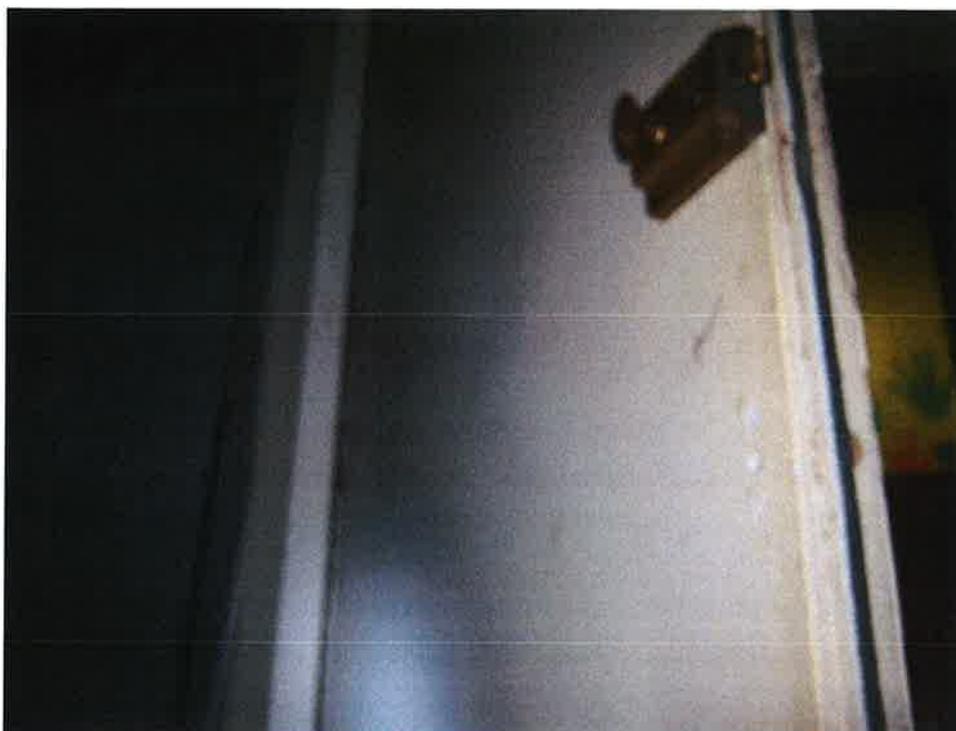
Sample No:	Sample 3-CS8991E/3	Picture 8
Survey Date:	12 <sup>th</sup> September 2012	
Location:	Second floor	
Position:	Stairwell cupboards doors	
Component:	Boarding	
Condition/ Protection:	-	
Accessibility:	-	
Analysis result:	<b>No asbestos detected</b>	
Risk Code:	-	
Recommended Action:	None

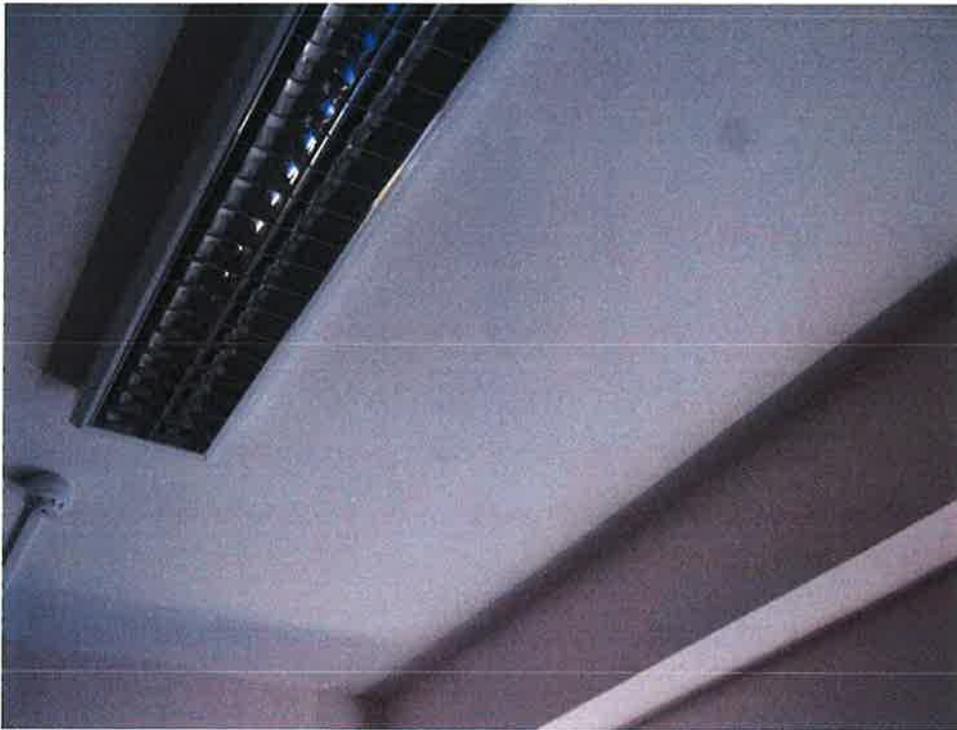
Sample No:	No sample	Picture 9
Survey Date:	12 <sup>th</sup> September 2012	
Location:	Throughout	
Position:	Ceilings	
Component:	Original lathe & plaster/plaster board panels	
Condition/ Protection:	-	
Accessibility:	-	
Analysis result:	-	
Risk Code:	-	
Recommended Action:	No asbestos materials suspected

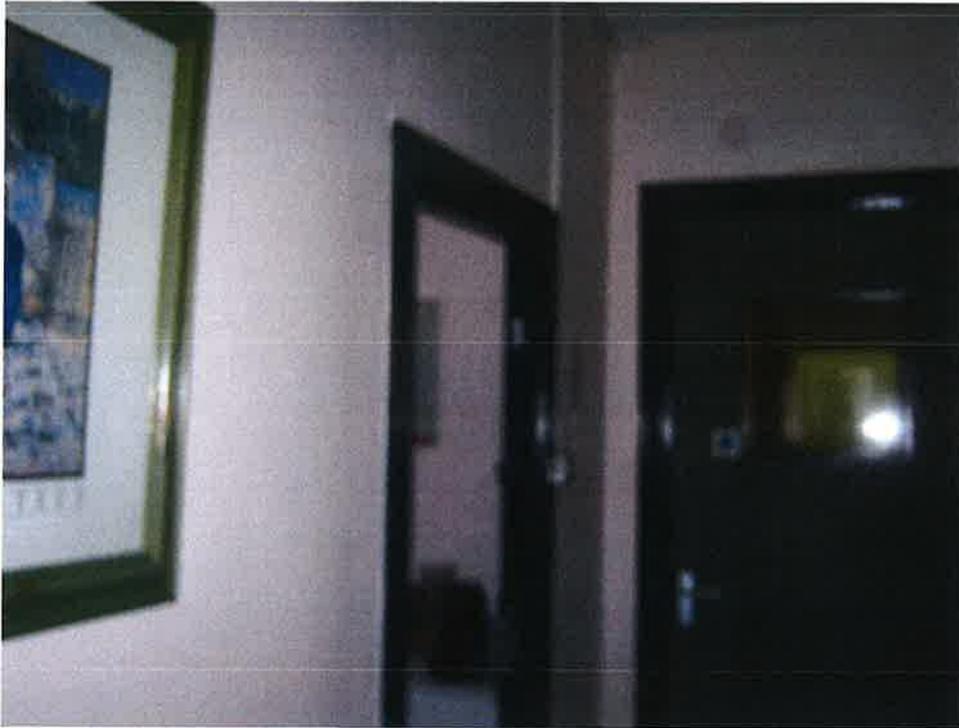
Sample No:	No sample	Picture 10
Survey Date:	12 <sup>th</sup> September 2012	
Location:	Throughout	
Position:	Walls	
Component:	Solid and plaster rendered/original lathe and plaster/plaster board panels	
Condition/ Protection:	-	
Accessibility:	-	
Presumption:	-	
Risk Code:	-	
Recommended Action:	No asbestos materials suspected

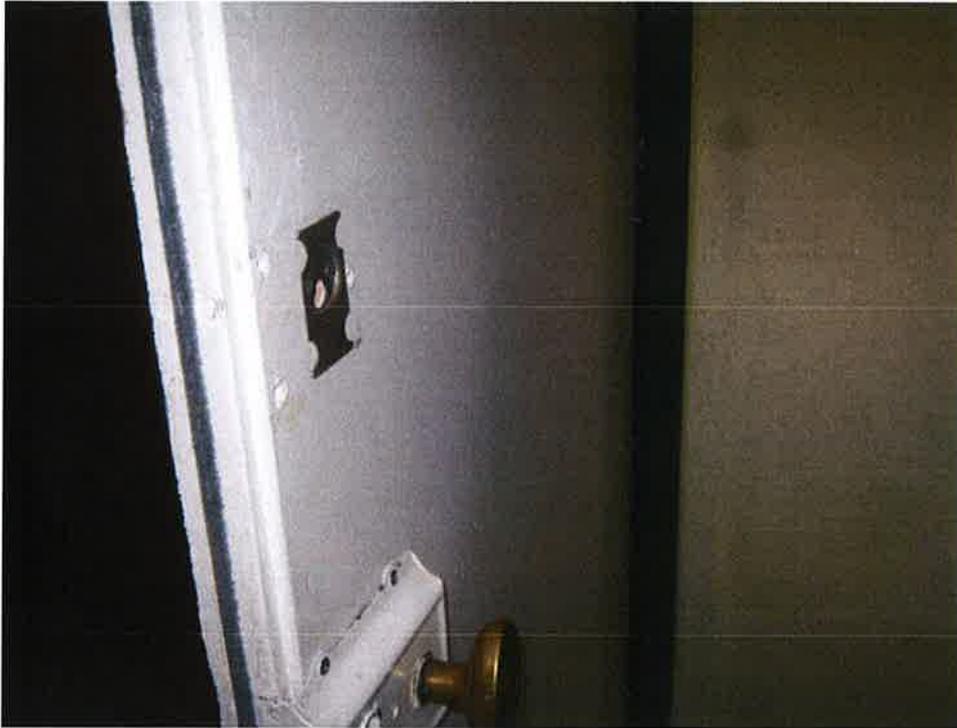
- #### First floor.
- 3.11 The insulation board material inner door lining was sampled from the kitchen door and following analysis the material was found to be non-asbestos Supalux board, a new technology product. **Sample 4-CS8991E/4 Picture 11**

Sample No:	Sample 4-CS8991E/4	Picture 11
Survey Date:	12 <sup>th</sup> September 2012	
Location:	First floor	
Position:	Kitchen door	
Component:	Boarding	
Condition/ Protection:	-	
Accessibility:	-	
Analysis result:	<b>No asbestos detected</b>	
Risk Code:	-	
Recommended Action:	None

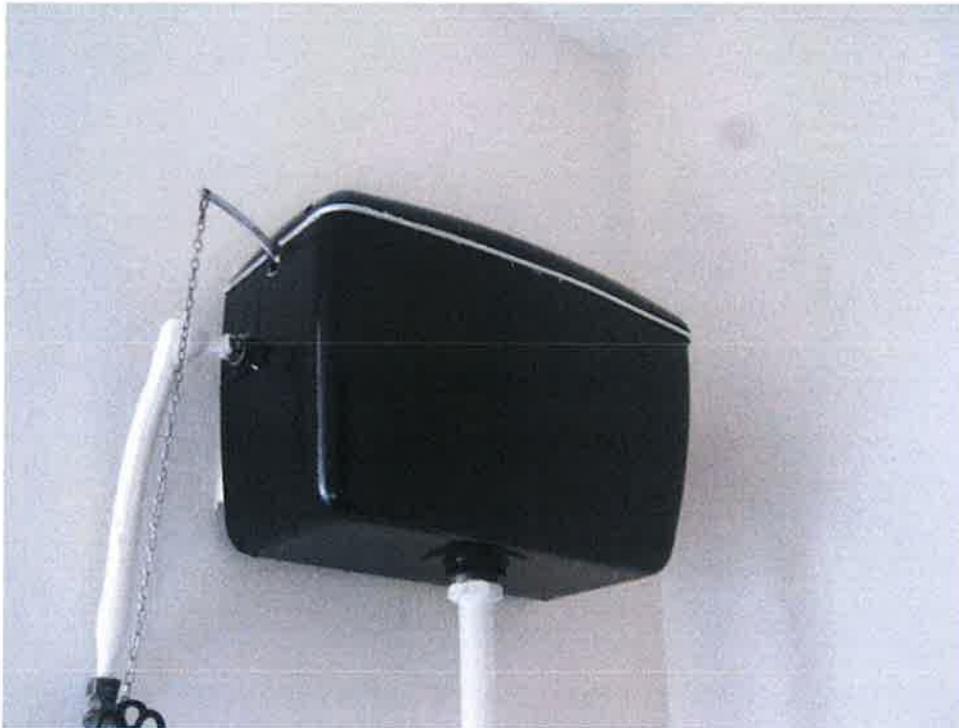
- 3.12 The toilet cistern was sampled from within the first floor toilet and following analysis the material was found to contain **Amosite (Brown) Asbestos** fibres. An identical toilet cistern was observed within the ground floor east wing toilet and can also be assumed to be an Asbestos

Sample No:	Sample 5-CS8991E/5	Picture 12
Survey Date:	12 <sup>th</sup> September 2012	
Location:	First floor (also ground floor east wing toilet)	
Position:	Toilet	
Component:	Toilet cistern	
Condition/ Protection:	Well bonded material	
Accessibility:	High	
Analysis result:	<b>Amosite (Brown) Asbestos</b>	
Risk Code:	D	
Recommended Action:	<p>Work on this material does not require a license.</p> <p>Work on this material may be notifiable to the appropriate enforcing authority.</p> <p>Disposal of asbestos waste by a licensed contractor only.</p> <p>All work must conform to the 'Control of</p>

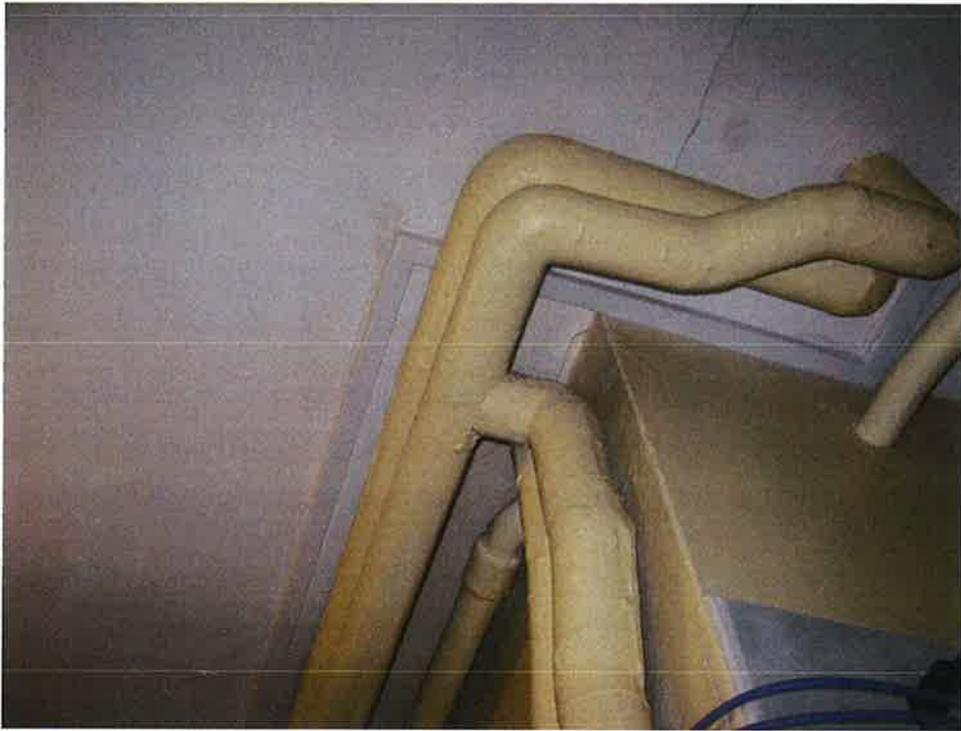
Sample No:	No sample	Picture 13
Survey Date:	12 <sup>th</sup> September 2012	
Location:	First floor	
Position:	To pipe runs	
Component:	Aconite pipe insulation	
Condition/ Protection:	-	
Accessibility:	-	
Analysis result:	-	
Risk Code:	-	
Recommended Action:	No asbestos materials suspected

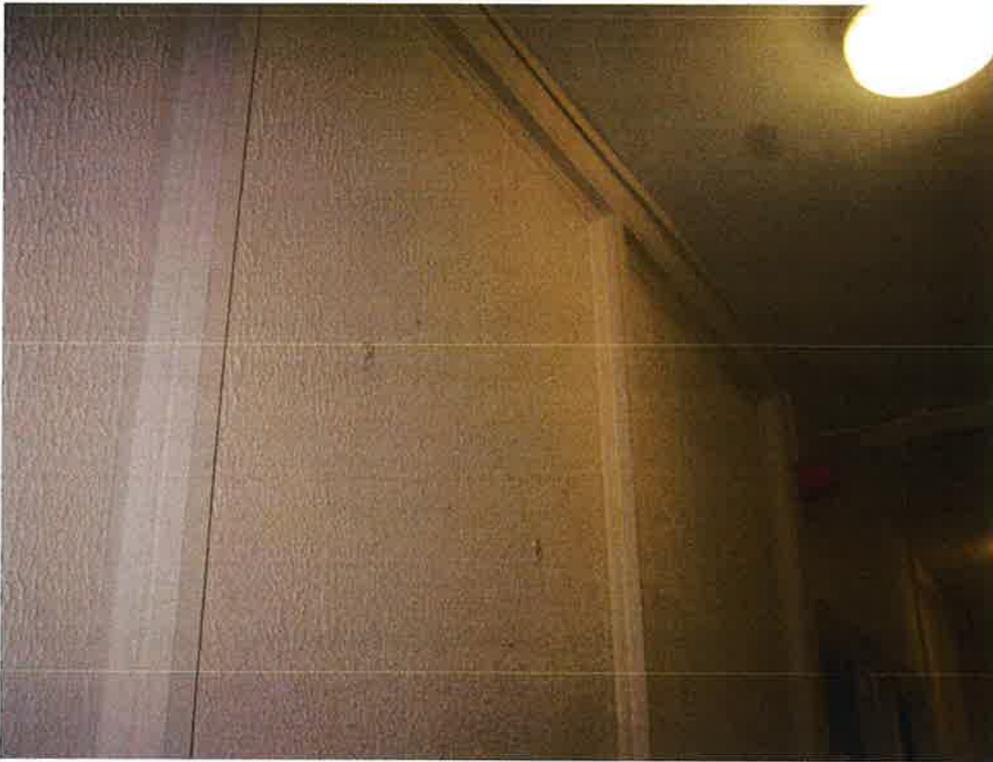
Sample No:	Sample 6-CS8991E/6	Picture 14
Survey Date:	12 <sup>th</sup> September 2012	
Location:	First floor	
Position:	Corridor glass panels	
Component:	Textured coating	
Condition/ Protection:	-	
Accessibility:	-	
Analysis result:	<b>No asbestos detected</b>	
Risk Code:	-	
Recommended Action:	None

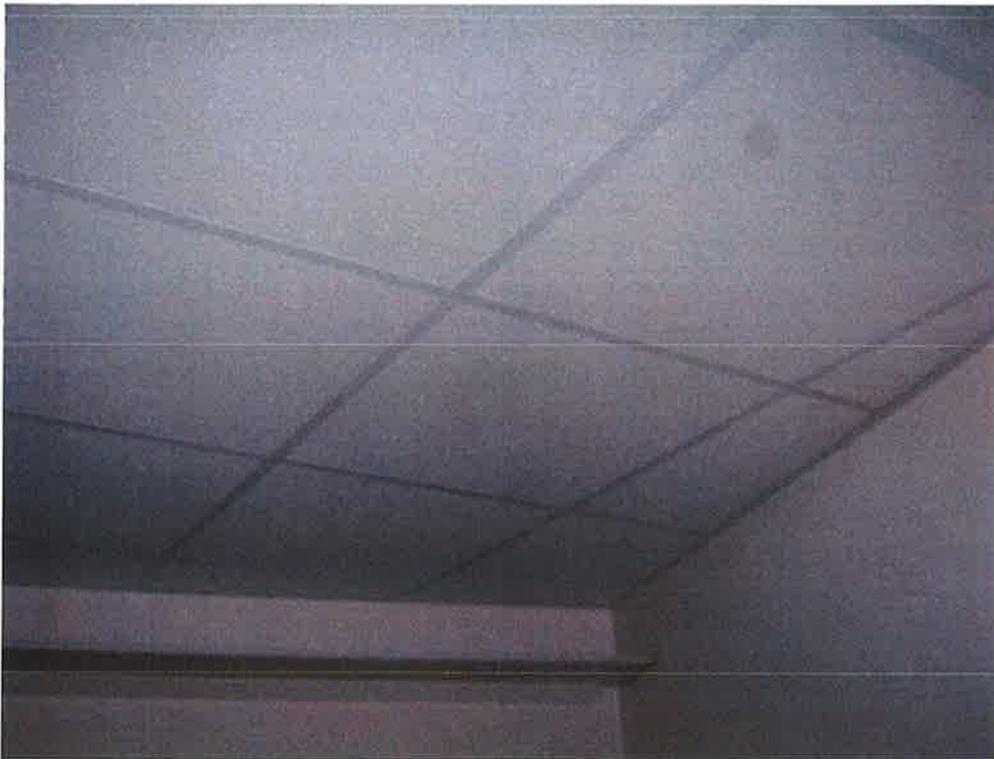
Sample No:	No sample	Picture 15
Survey Date:	12 <sup>th</sup> September 2012	
Location:	First floor	
Position:	To suspended ceiling	
Component:	MMMF ceiling tiles	
Condition/ Protection:	-	
Accessibility:	-	
Analysis result:	-	
Risk Code:	-	
Recommended Action:	No asbestos materials suspected

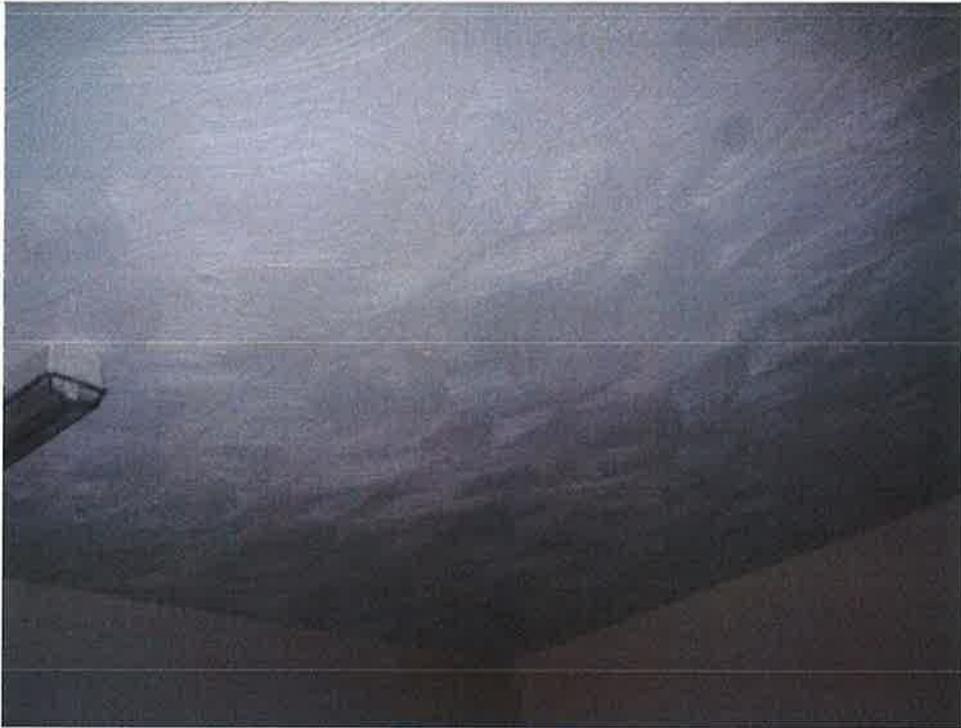
Sample No:	Sample 7-CS8991E/7	Picture 16
Survey Date:	12 <sup>th</sup> September 2012	
Location:	First floor	
Position:	Various ceilings	
Component:	Textured coating	
Condition/ Protection:	-	
Accessibility:	-	
Analysis result:	<b>No asbestos detected</b>	
Risk Code:	-	
Recommended Action:	None

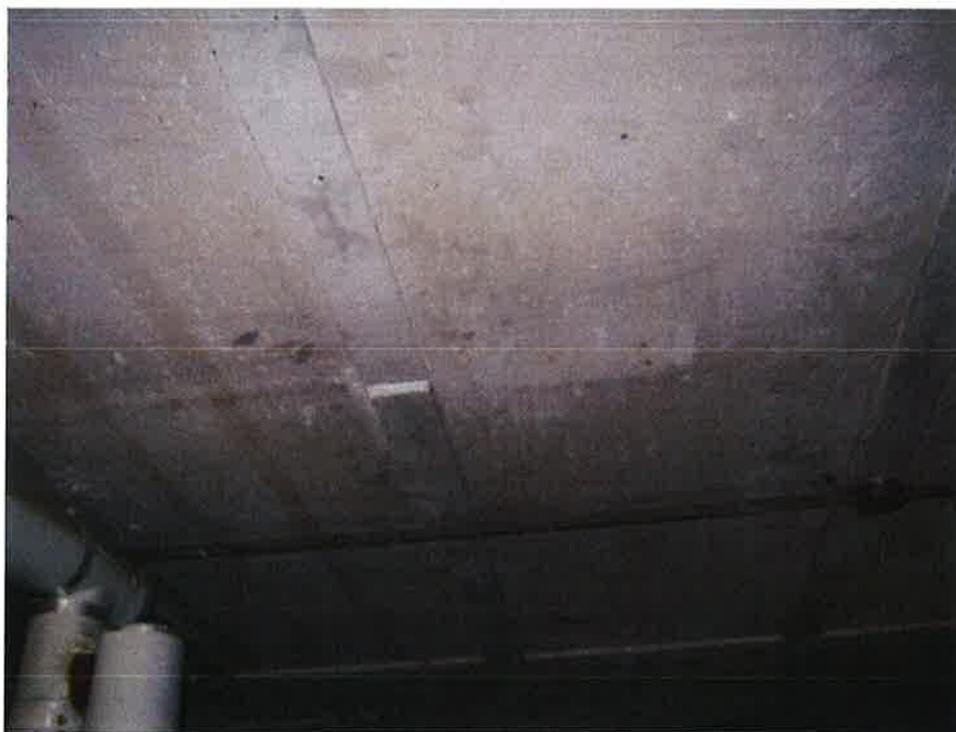
- 3.18 The insulation board material ceiling panels were sampled from the boiler room and following analysis the material was found to contain **Amosite (Brown)** and **Chrysotile (White) Asbestos** fibres, the boarding was seen to be in good condition and unsealed. **Sample 8-CS8991E/8 Picture 17**

Sample No:	Sample 8-CS88891E/8	Picture 17
Survey Date:	12 <sup>th</sup> September 2012	
Location:	Basement level boiler room	
Position:	Ceiling	
Component:	Boarding	
Condition/ Protection:	Good/unsealed	
Accessibility:	High	
Analysis result:	<b>Amosite (Brown) and Chrysotile (White) Asbestos</b>	
Risk Code:	C	
Recommended Action:	<p>Work on this material requires a license.</p> <p>Work on this material is notifiable to the appropriate enforcing authority.</p> <p>Disposal of asbestos waste by a licensed contractor only.</p> <p>All work must conform to the 'Control of Asbestos Regulations 2012'.</p>

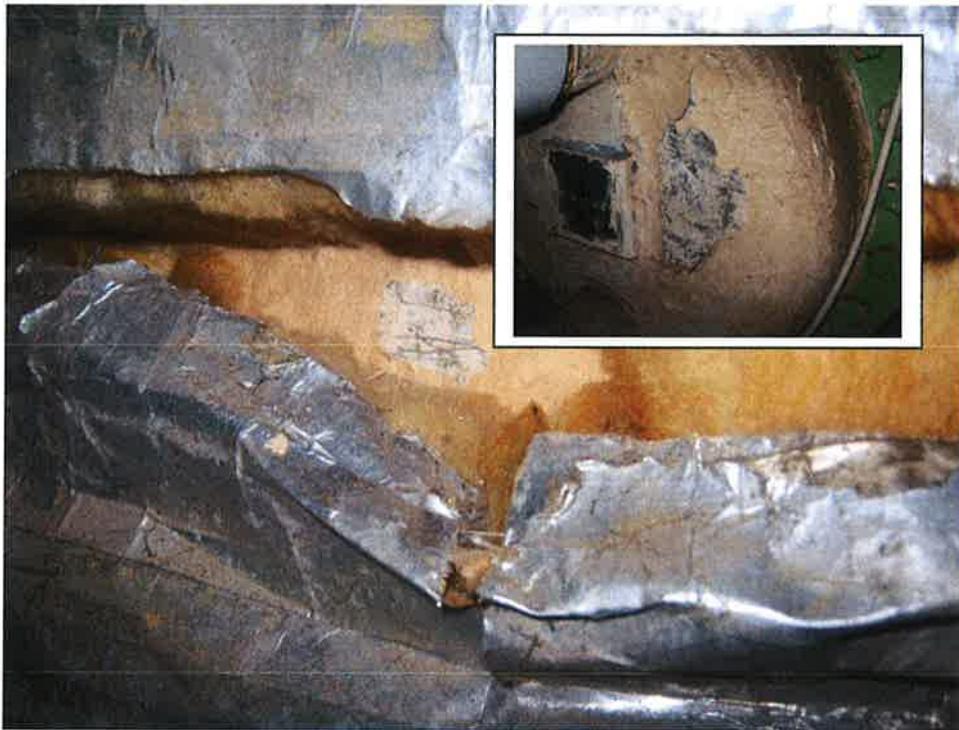
- 3.19 Insulation material residue was sampled from beneath the MMMF insulation to the calorifiers and following analysis the material was found to be non-asbestos. **Sample 9-CS8991E/9 Picture 18**

Sample No:	Sample 9-CS8991E/9	Picture 18
Survey Date:	12 <sup>th</sup> September 2012	
Location:	Basement level boiler room	
Position:	To calorifiers	
Component:	Insulation residue	
Condition/ Protection:	-	
Accessibility:	-	
Analysis result:	<b>No asbestos detected</b>	
Risk Code:	-	
Recommended Action:	None

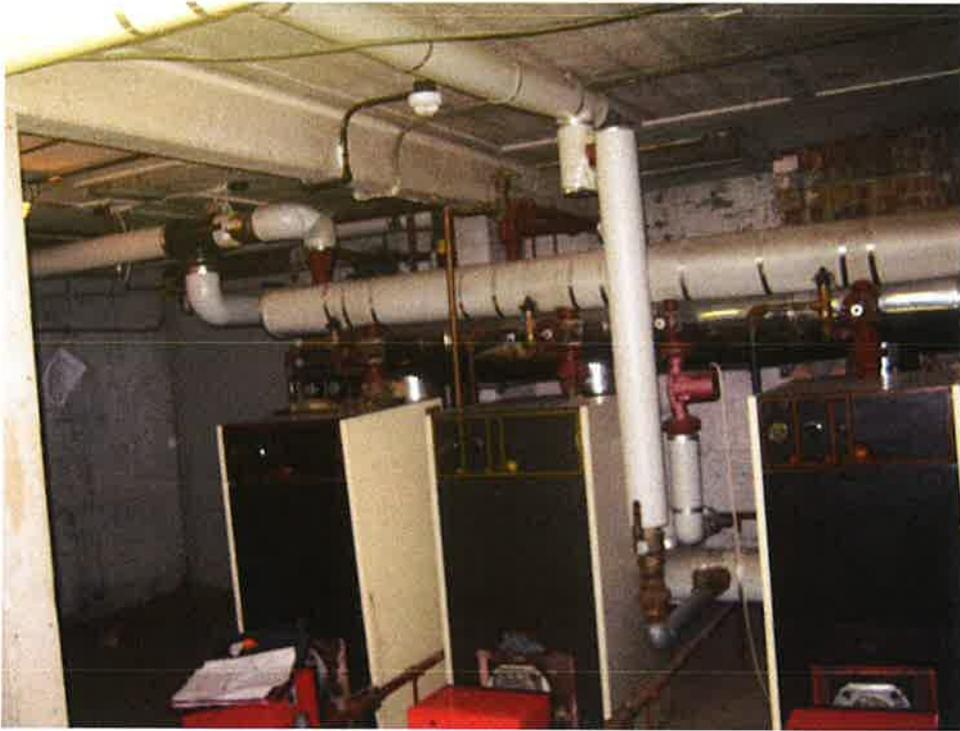
Sample No:	No sample	Picture 19
Survey Date:	12 <sup>th</sup> September 2012	
Location:	Basement level boiler room	
Position:	-	
Component:	Modern boilers/MMMF pipe insulation	
Condition/ Protection:	-	
Accessibility:	-	
Analysis result:	-	
Risk Code:	-	
Recommended Action:	No asbestos materials suspected

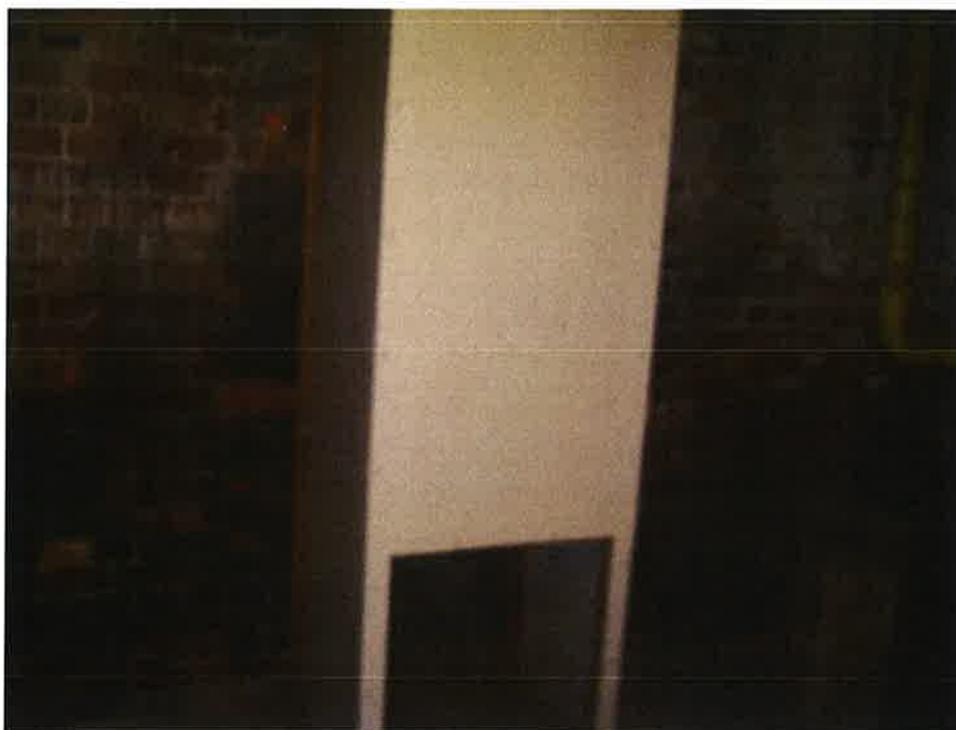
Sample No:	Sample 10-CS8991E/10	Picture 20
Survey Date:	12 <sup>th</sup> September 2012	
Location:	Basement level boiler room	
Position:	Service cladding	
Component:	Boarding	
Condition/ Protection:	-	
Accessibility:	-	
Analysis result:	<b>No asbestos detected</b>	
Risk Code:	-	
Recommended Action:	None

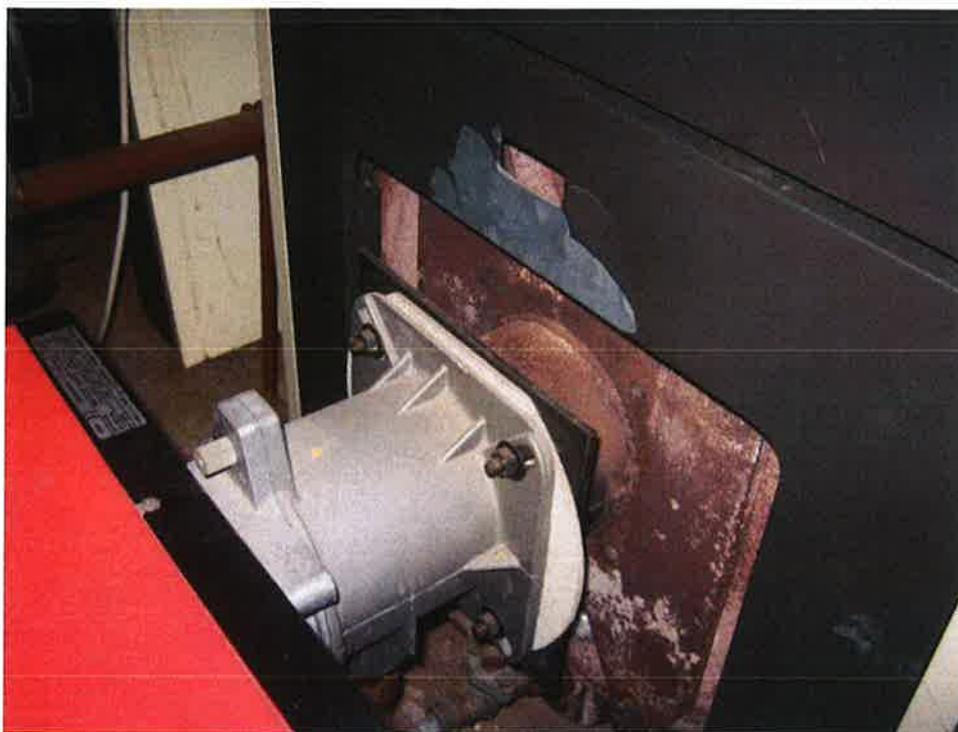
- 3.22 The insulation board material gasket was sampled from the boiler fronts and following analysis the material was found to be non-asbestos Supalux board, a new technology product. **Sample 11-CS8991E/11 Picture 21**

Sample No:	Sample 11-CS8991E/11	Picture 21
Survey Date:	12 <sup>th</sup> September 2012	
Location:	Basement level boiler room	
Position:	To boilers (gasket)	
Component:	Boarding	
Condition/ Protection:	-	
Accessibility:	-	
Analysis result:	<b>No asbestos detected</b>	
Risk Code:	-	
Recommended Action:	None

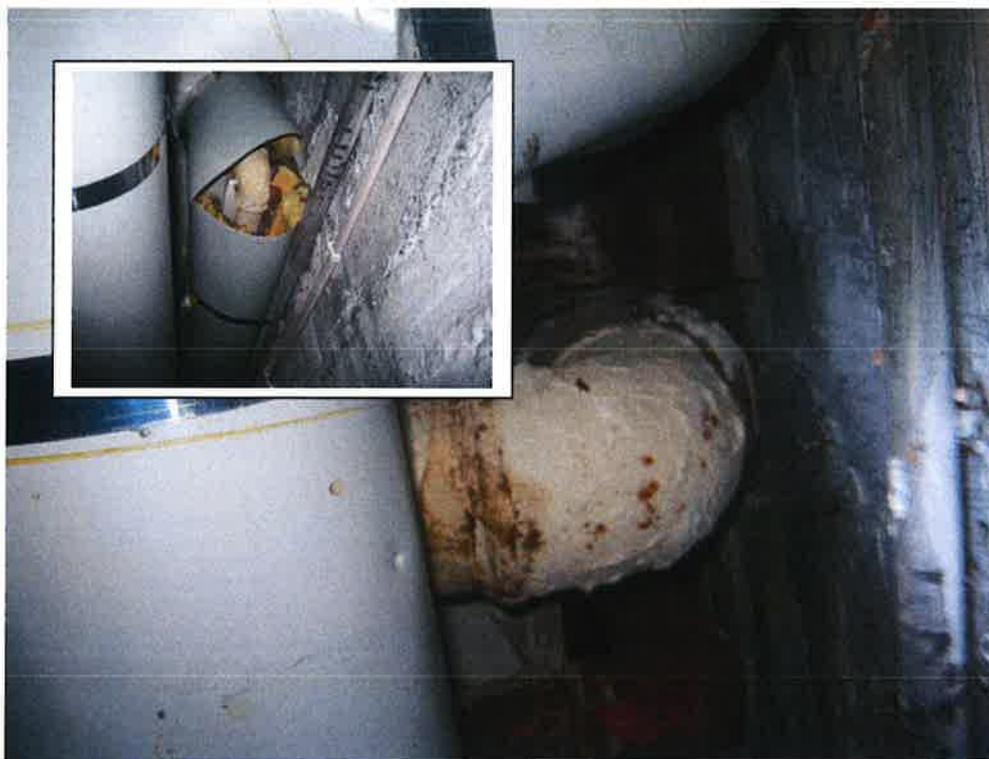
- 3.23 Insulation material residue was multiple sampled from various pipe runs (beneath the MMMF insulation) throughout the boiler room and following analysis the material was found to contain **Amosite (Brown) Asbestos** fibres, the material was seen to be in poor condition and part paint sealed. **Sample 12-CS8991E/12 Picture 22**

Sample No:	Sample 12-CS8991E/12	Picture 22
Survey Date:	12 <sup>th</sup> September 2012	
Location:	Basement level boiler room	
Position:	To pipe runs	
Component:	Insulation residue	
Condition/ Protection:	Poor/part paint sealed	
Accessibility:	High	
Analysis result:	<b>Amosite (Brown) Asbestos</b>	
Risk Code:	A	
Recommended Action:	<p>Work on this material requires a license.</p> <p>Work on this material is notifiable to the appropriate enforcing authority.</p> <p>Disposal of asbestos waste by a licensed contractor only.</p> <p>All work must conform to the 'Control of Asbestos Regulations 2012'.</p>

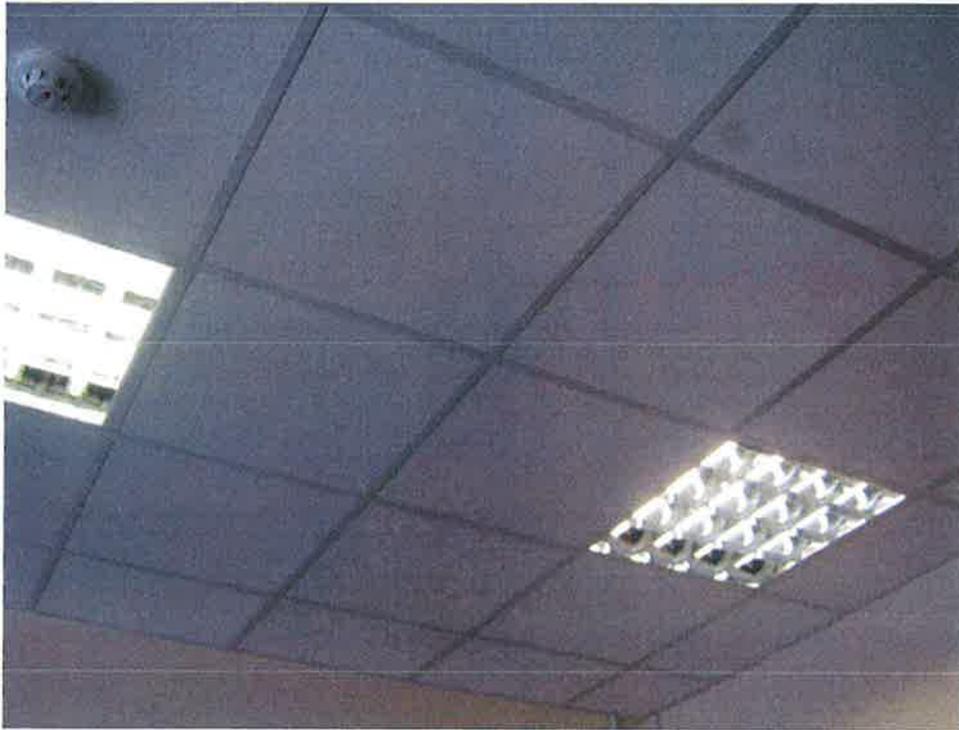
Sample No:	No sample	Picture 23
Survey Date:	12 <sup>th</sup> September 2012	
Location:	Ground floor	
Position:	Suspended ceilings	
Component:	MMMF ceiling tiles	
Condition/ Protection:	-	
Accessibility:	-	
Analysis result:	-	
Risk Code:	-	
Recommended Action:	No asbestos materials suspected

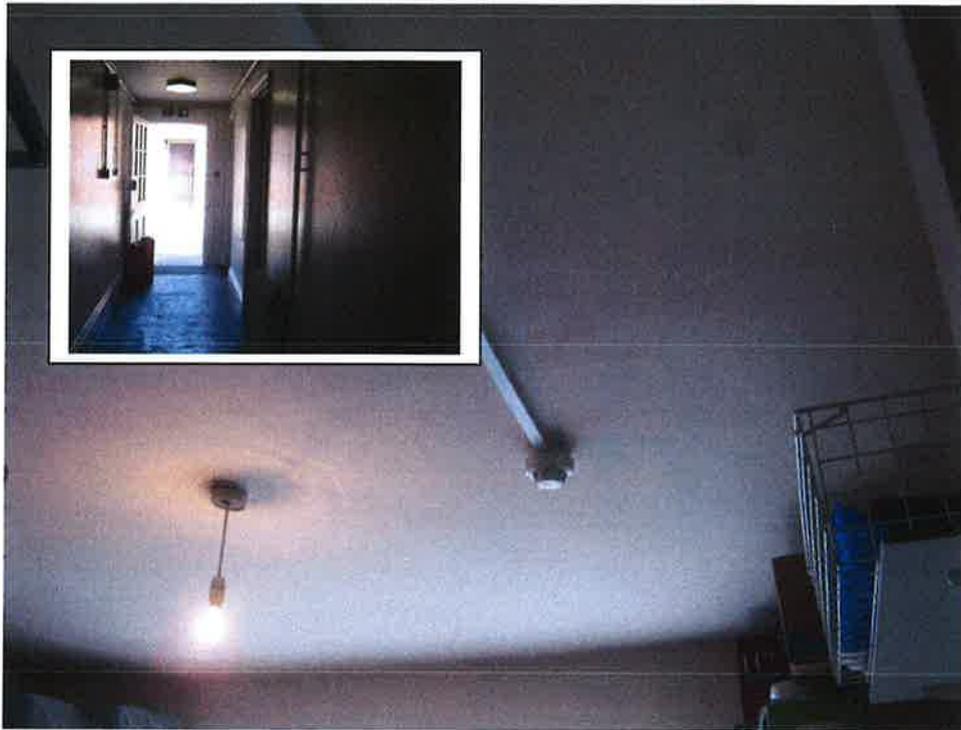
Sample No:	No sample	Picture 24
Survey Date:	12 <sup>th</sup> September 2012	
Location:	Ground floor	
Position:	Ceilings/walls	
Component:	Solid and plaster rendered/original lathe and plaster/plaster board panels	
Condition/ Protection:	-	
Accessibility:	-	
Analysis result:	-	
Risk Code:	-	
Recommended Action:	No asbestos materials suspected

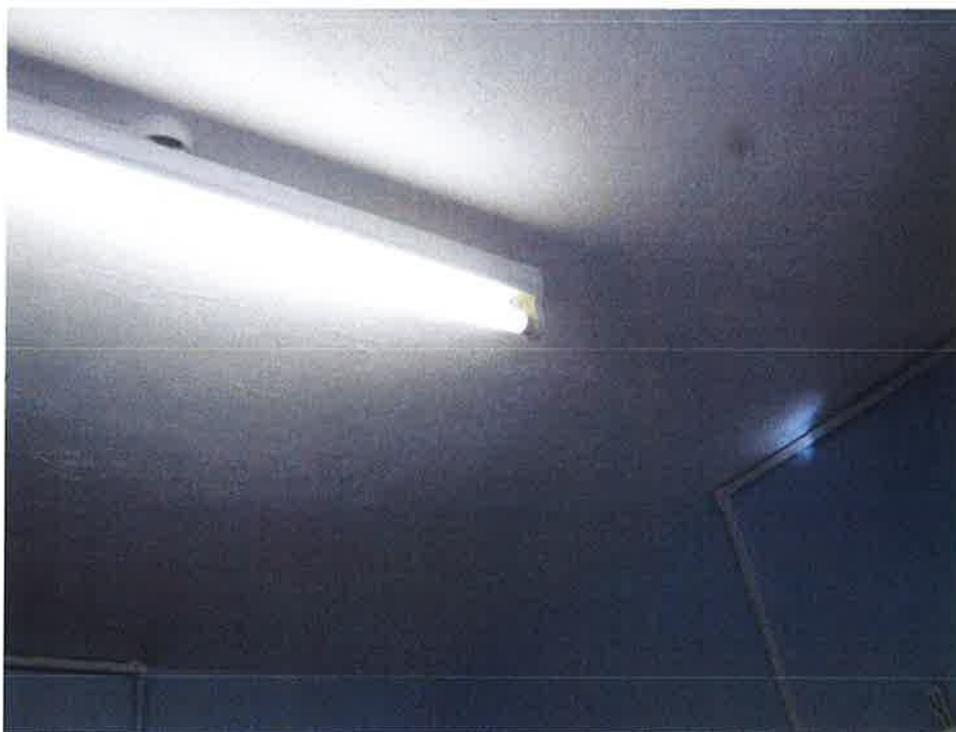
Sample No:	Sample 13-CS8991E/13	Picture 25
Survey Date:	12 <sup>th</sup> September 2012	
Location:	Ground floor	
Position:	Copy room ceiling	
Component:	Textured coating	
Condition/ Protection:	-	
Accessibility:	-	
Analysis result:	<b>No asbestos detected</b>	
Risk Code:	-	
Recommended Action:	None

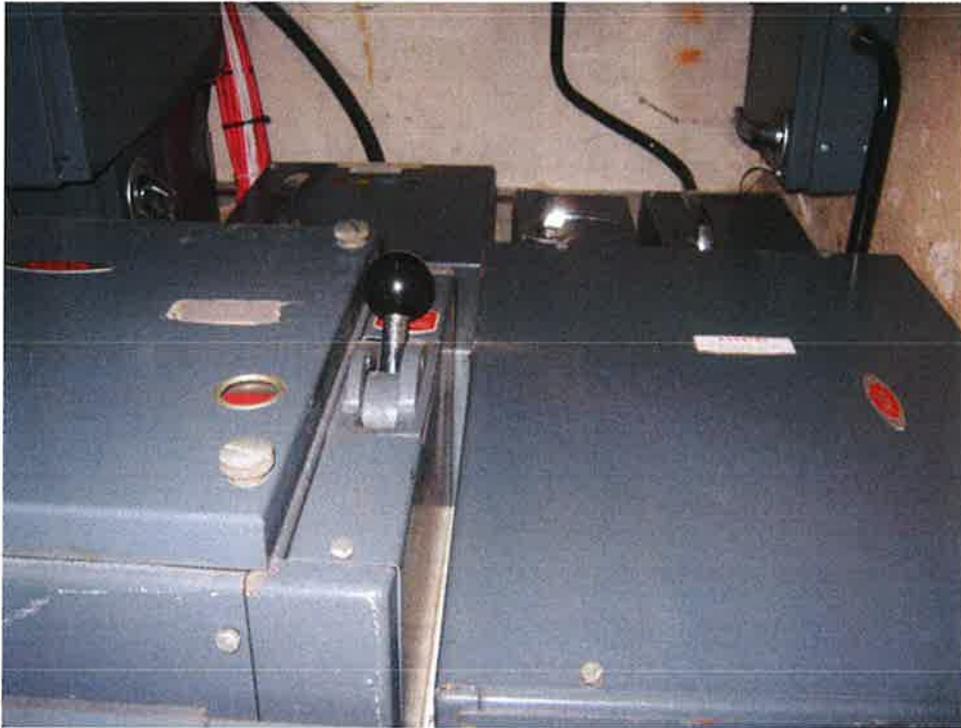
Sample No:	Visual 1	Picture 26
Survey Date:	12 <sup>th</sup> September 2012	
Location:	Ground floor reception electrical intake	
Position:	Within fuse boxes	
Component:	Suspected rope products	
Condition/ Protection:	Unsealed	
Accessibility:	Low (high to maintenance)	
Presumption:	<b>Chrysotile (White) Asbestos</b>	
Risk Code:	D	
Recommended Action:	Work on this material does not require a license. Work on this material may be notifiable to the appropriate enforcing authority. Disposal of asbestos waste by a licensed contractor only. All work must conform to the 'Control of Asbestos Regulations 2012'.

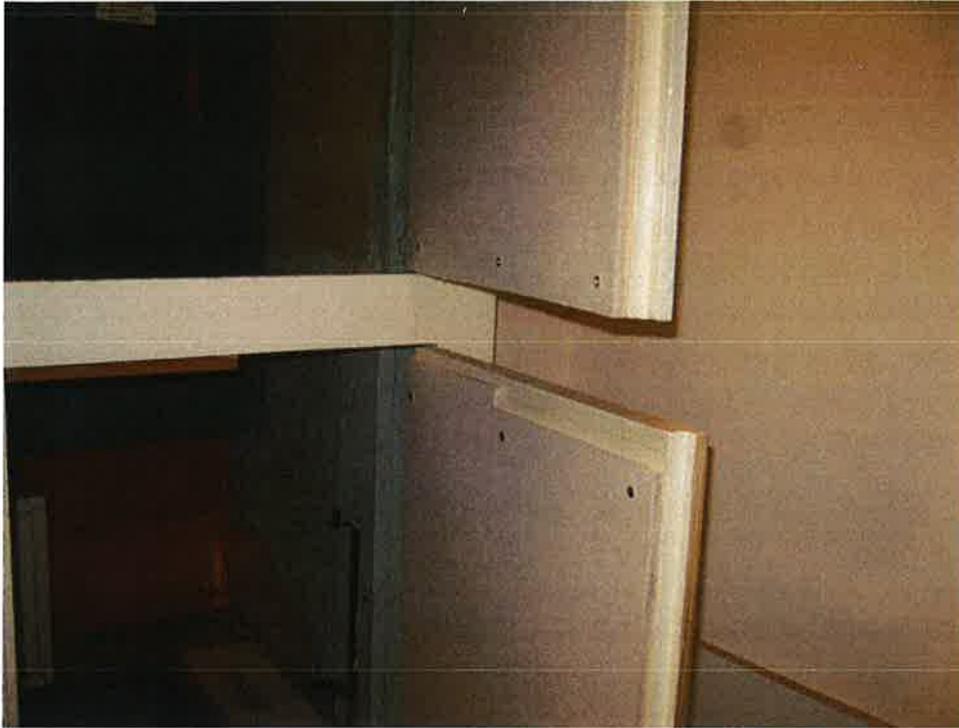
- 3.28 The insulation board material inner door linings were sampled from the reception main electrical intake doors and following analysis the material was found to be non-asbestos Supalux board, a new technology product. **Sample 14-CS8991E/14 Picture 27**

Sample No:	Sample 14-CS8991E/14	Picture 27
Survey Date:	12 <sup>th</sup> September 2012	
Location:	Ground floor	
Position:	Reception electrical intake inner doors	
Component:	Boarding	
Condition/ Protection:	-	
Accessibility:	-	
Analysis result:	<b>No asbestos detected</b>	
Risk Code:	-	
Recommended Action:	None
