**AMSTECH** CONTRACTS LIMITED

**A MANAGEMENT SURVEY TO LOCATE AND  
IDENTIFY  
ASBESTOS BEARING MATERIALS  
At  
ST JOHN'S SCHOOL  
FIRLE ROAD  
SEAFORD  
EAST SUSSEX  
BN25 2HU**

**Survey Report No. CS8991E**

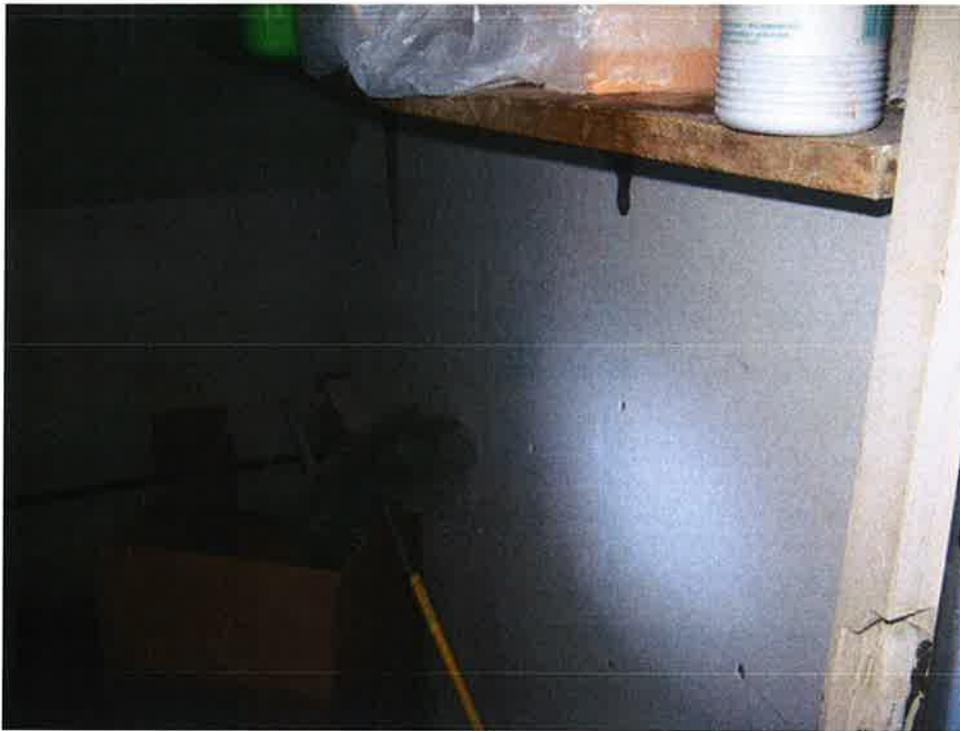
- 3.29 The insulation board material wall side panel was sampled from within the ground floor below stairs cupboard and following analysis the material was found to be non-asbestos Supalux board, a new technology product. **Sample 15-CS8991E/15 Picture 28**

Sample No:	Sample 15-CS8991E/15	Picture 28
Survey Date:	12 <sup>th</sup> September 2012	
Location:	Ground floor	
Position:	Below stairs cupboard side panels	
Component:	Boarding	
Condition/ Protection:	-	
Accessibility:	-	
Analysis result:	<b>No asbestos detected</b>	
Risk Code:	-	
Recommended Action:	None

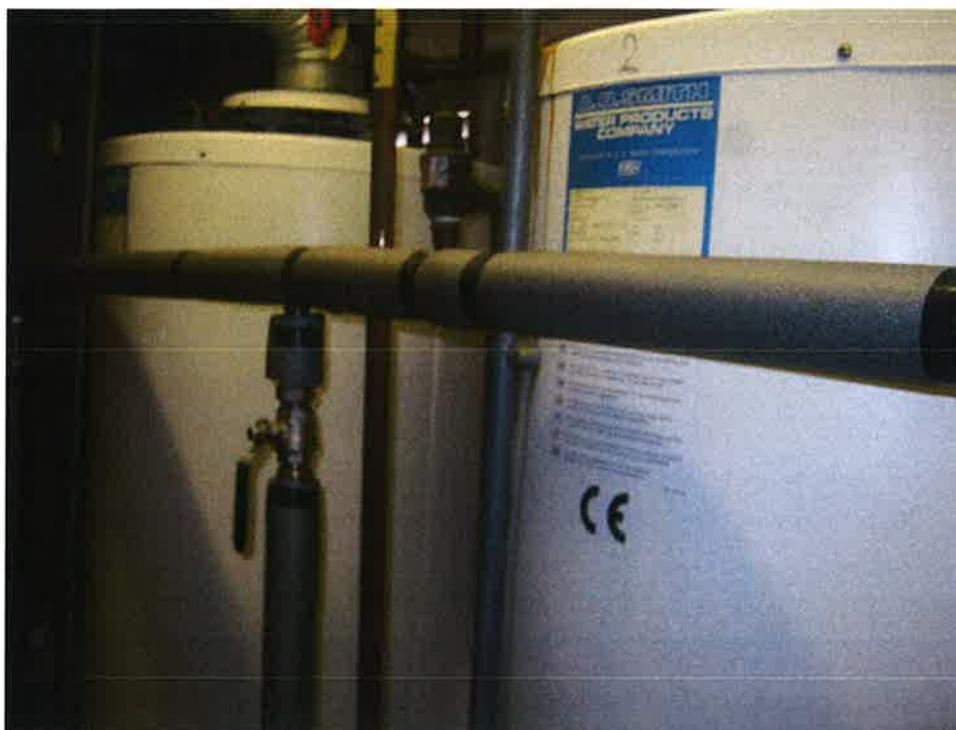
Sample No:	No sample	Picture 29
Survey Date:	12 <sup>th</sup> September 2012	
Location:	Ground floor	
Position:	Boiler room	
Component:	Modern plant	
Condition/ Protection:	-	
Accessibility:	-	
Analysis result:	-	
Risk Code:	-	
Recommended Action:	No asbestos materials suspected

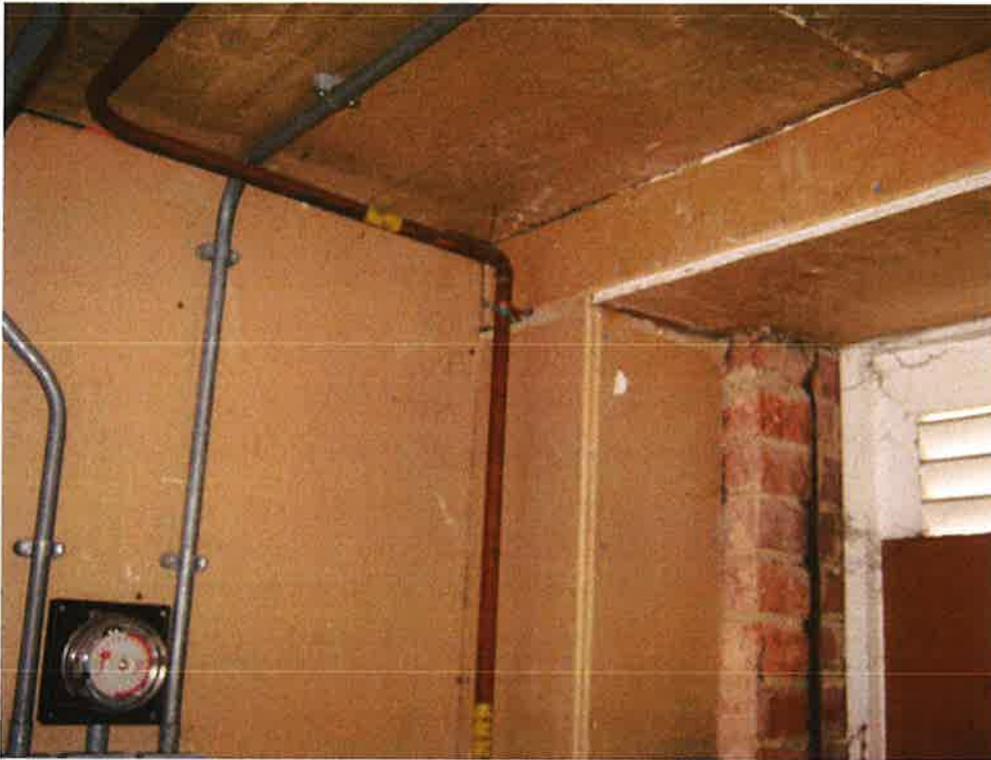
Sample No:	No sample	Picture 30
Survey Date:	12 <sup>th</sup> September 2012	
Location:	Ground floor	
Position:	Boiler room	
Component:	Plaster board internal cladding	
Condition/ Protection:	-	
Accessibility:	-	
Analysis result:	-	
Risk Code:	-	
Recommended Action:	No asbestos materials suspected

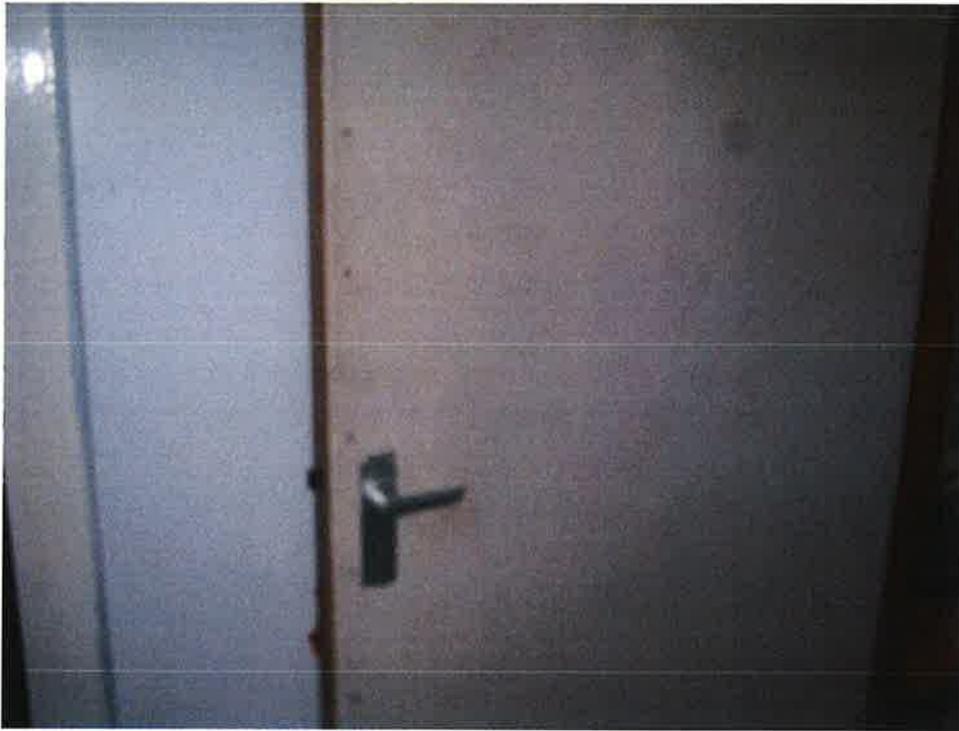
- 3.32 The insulation board material inner door lining was sampled from the resource room door and following analysis the material was found to be non-asbestos Supalux board, a new technology product. **Sample 16-CS8991E/16 Picture 31**

Sample No:	Sample 16-CS8991E/16	Picture 31
Survey Date:	12 <sup>th</sup> September 2012	
Location:	Ground floor	
Position:	Resource room door	
Component:	Boarding	
Condition/ Protection:	-	
Accessibility:	-	
Analysis result:	<b>No asbestos detected</b>	
Risk Code:	-	
Recommended Action:	None

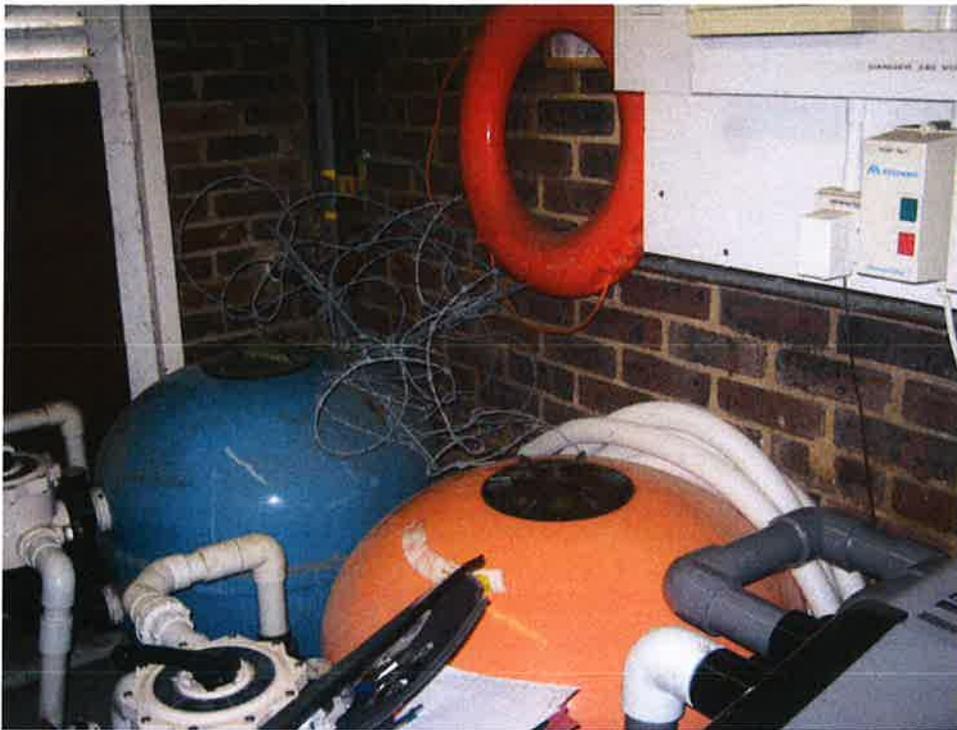
Sample No:	No sample	Picture 32
Survey Date:	12 <sup>th</sup> September 2012	
Location:	Ground floor	
Position:	Swimming pool plant room	
Component:	Modern plant	
Condition/ Protection:	-	
Accessibility:	-	
Analysis result:	-	
Risk Code:	-	
Recommended Action:	No asbestos materials suspected

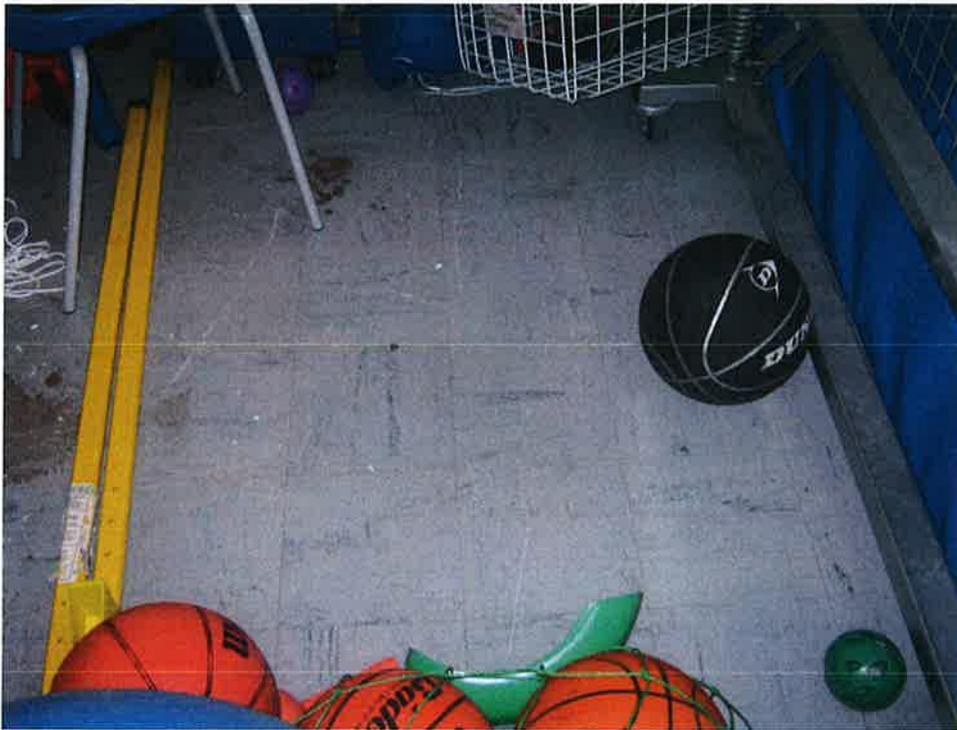
Sample No:	Sample 17-CS8991E/17	Picture 33
Survey Date:	12 <sup>th</sup> September 2012	
Location:	Ground floor	
Position:	Sports hall store	
Component:	Bitumen floor tile adhesive	
Condition/ Protection:	Well bonded material	
Accessibility:	High	
Analysis result:	<b>Chrysotile (White) Asbestos</b>	
Risk Code:	D	
Recommended Action:	<p>Work on this material does not require a license.</p> <p>Work on this material may be notifiable to the appropriate enforcing authority.</p> <p>Disposal of asbestos waste by a licensed contractor only.</p> <p>All work must conform to the 'Control of Asbestos Regulations 2012'.</p>

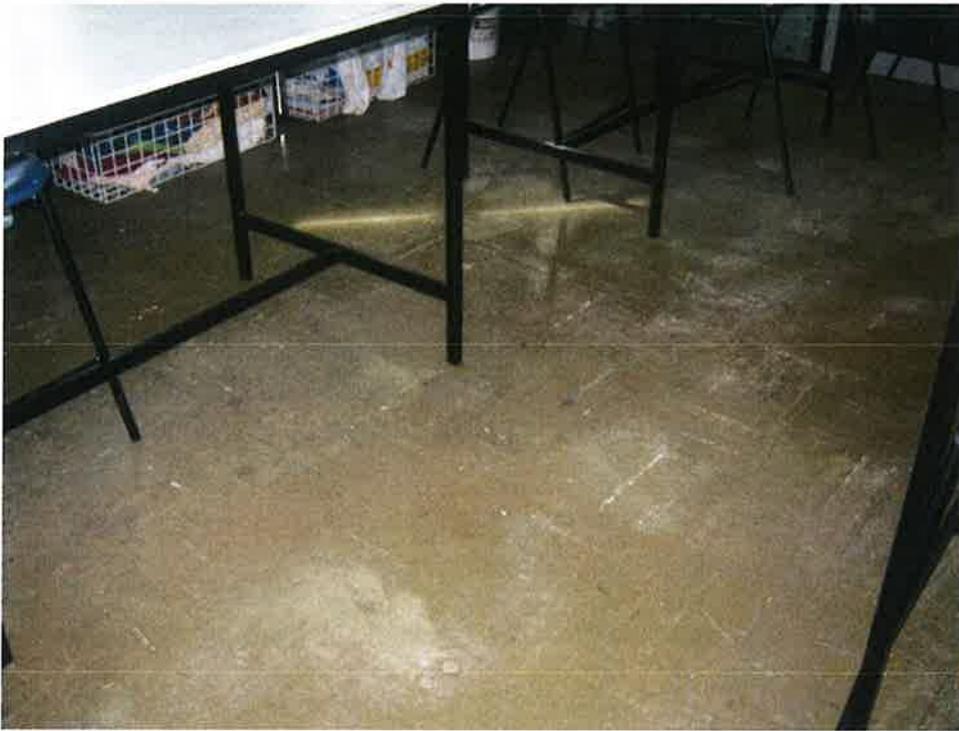
- 3.32 Green vinyl floor tiles were observed to various east wing rooms and sampled from the server room and following analysis the material was found to be non-asbestos. **Sample 18-CS8991E/18 Picture 34**

Sample No:	Sample 18-CS8991E/18	Picture 34
Survey Date:	12 <sup>th</sup> September 2012	
Location:	Ground floor	
Position:	East wing-various rooms	
Component:	Green vinyl floor tiles	
Condition/ Protection:	-	
Accessibility:	-	
Analysis result:	<b>No asbestos detected</b>	
Risk Code:	-	
Recommended Action:	None

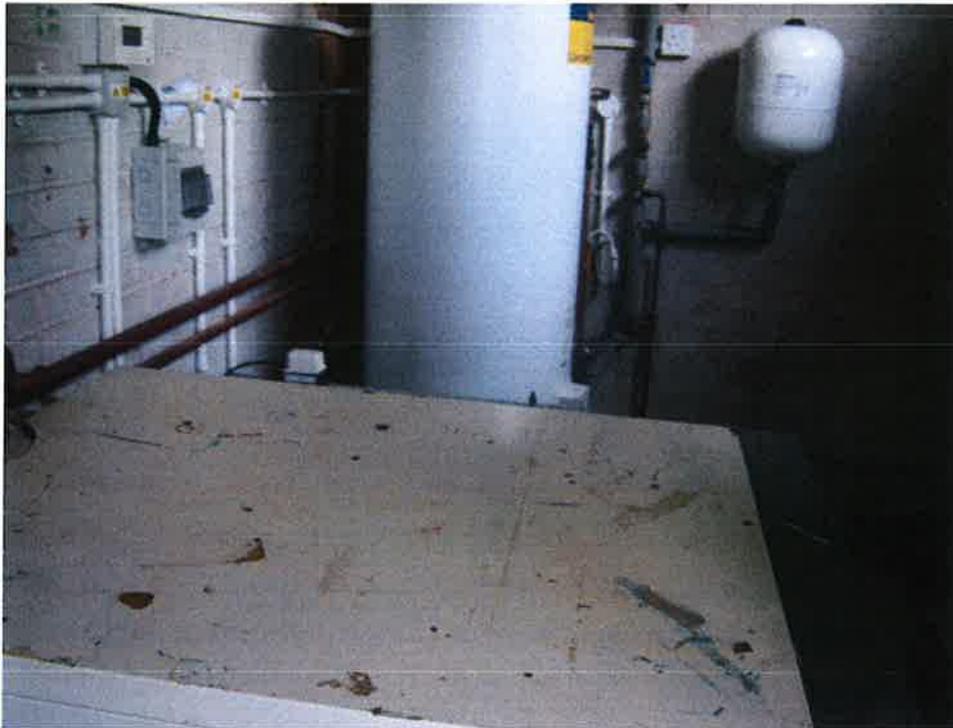
Sample No:	No sample	Picture 35
Survey Date:	12 <sup>th</sup> September 2012	
Location:	Ground floor	
Position:	Workshop plant room	
Component:	Modern plant	
Condition/ Protection:	-	
Accessibility:	-	
Analysis result:	-	
Risk Code:	-	
Recommended Action:	No asbestos materials suspected

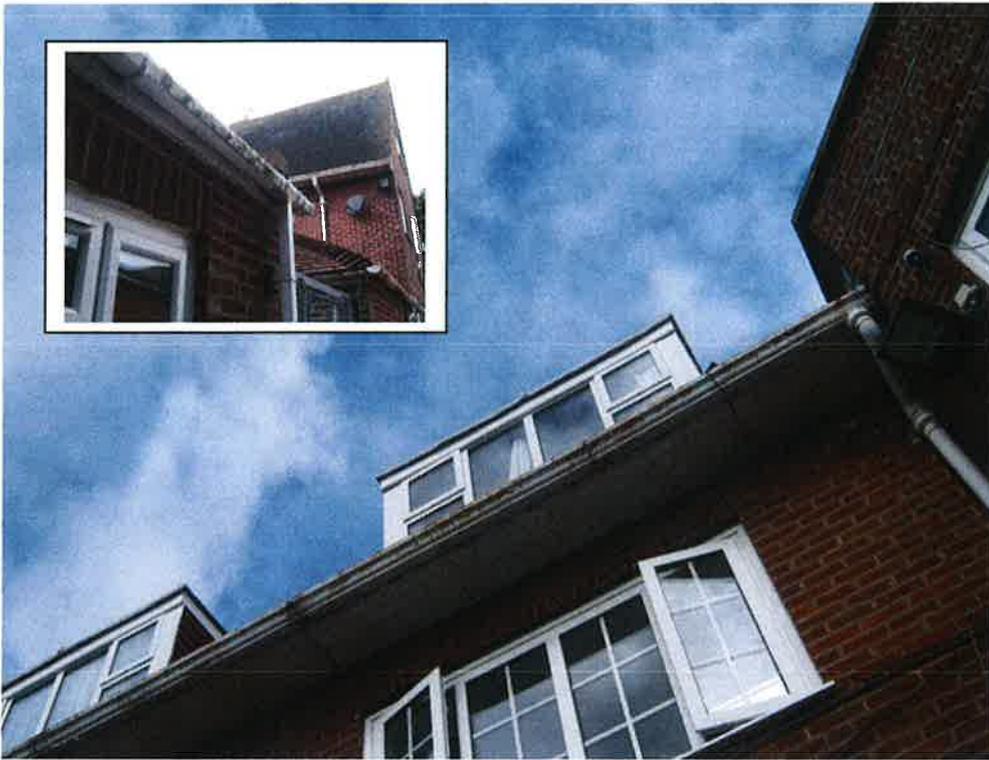
Sample No:	No sample	Picture 36
Survey Date:	12 <sup>th</sup> September 2012	
Location:	Main building	
Position:	External	
Component:	Timber soffits/plastic rain water goods	
Condition/ Protection:	-	
Accessibility:	-	
Analysis result:	-	
Risk Code:	-	
Recommended Action:	No asbestos materials suspected

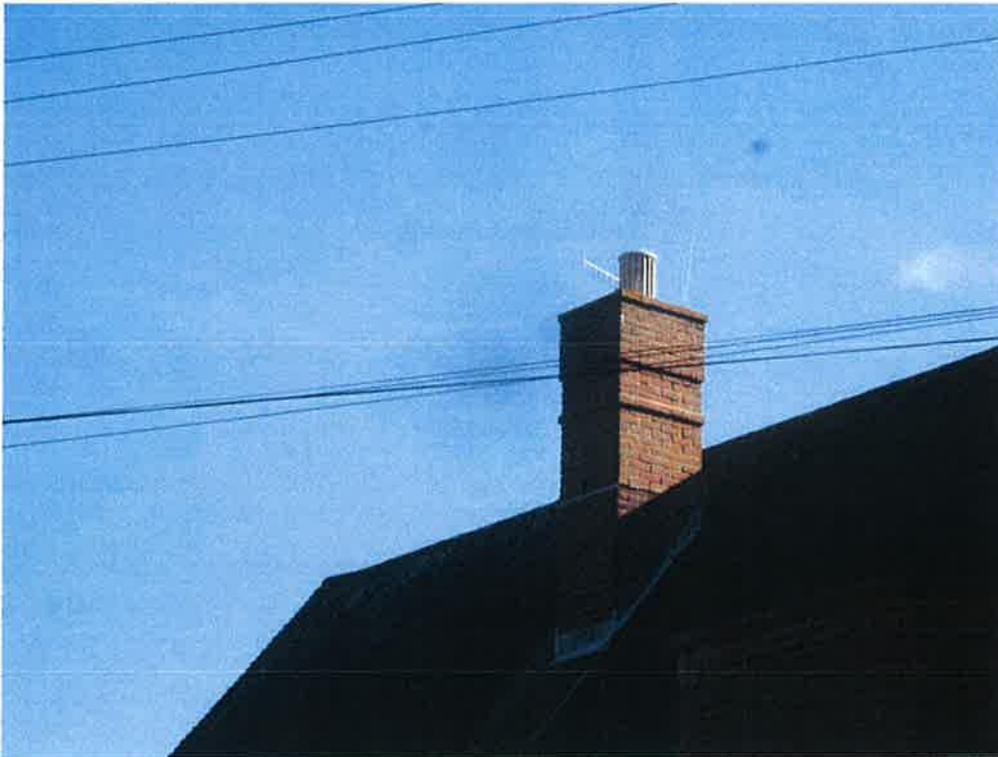
Sample No:	Visual 2	Picture 37
Survey Date:	12 <sup>th</sup> September 2012	
Location:	External	
Position:	West wing chimney stack	
Component:	Suspected cement flue cowl	
Condition/ Protection:	Good/unsealed	
Accessibility:	Low	
Presumption:	<b>Chrysotile (White) Asbestos</b>	
Risk Code:	D	
Recommended Action:	<p>Work on this material does not require a license.</p> <p>Work on this material may be notifiable to the appropriate enforcing authority.</p> <p>Disposal of asbestos waste by a licensed contractor only.</p> <p>All work must conform to the 'Control of Asbestos Regulations 2012'</p>

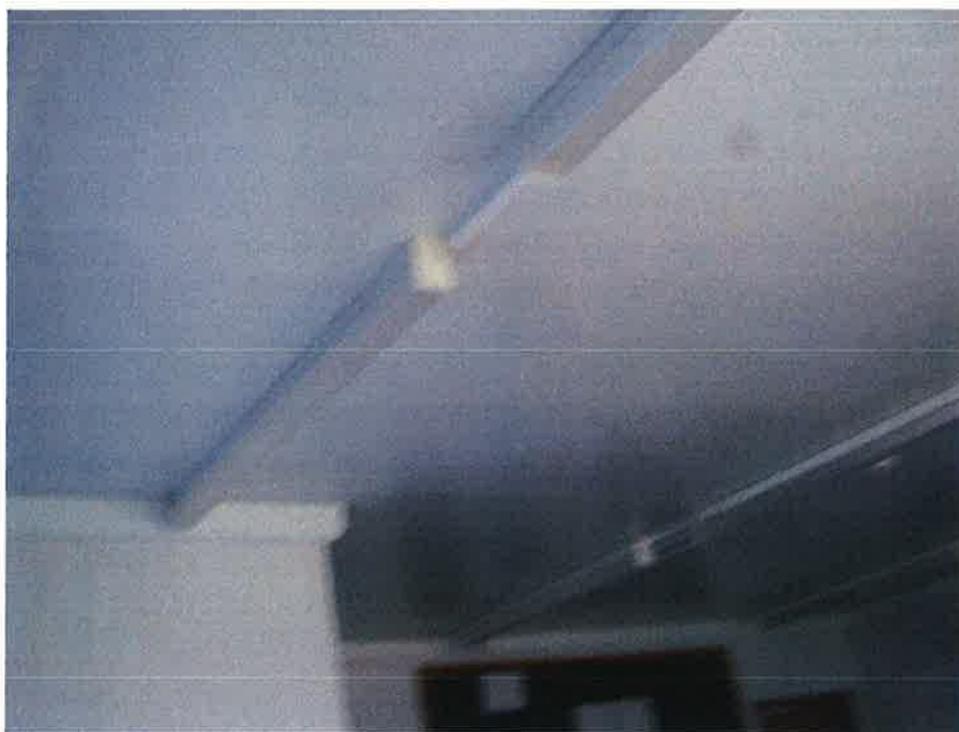
Sample No:	No sample	Picture 38
Survey Date:	12 <sup>th</sup> September 2012	
Location:	Youth centre	
Position:	Ceilings	
Component:	Plaster board panels	
Condition/ Protection:	-	
Accessibility:	-	
Analysis result:	-	
Risk Code:	-	
Recommended Action:	No asbestos materials suspected

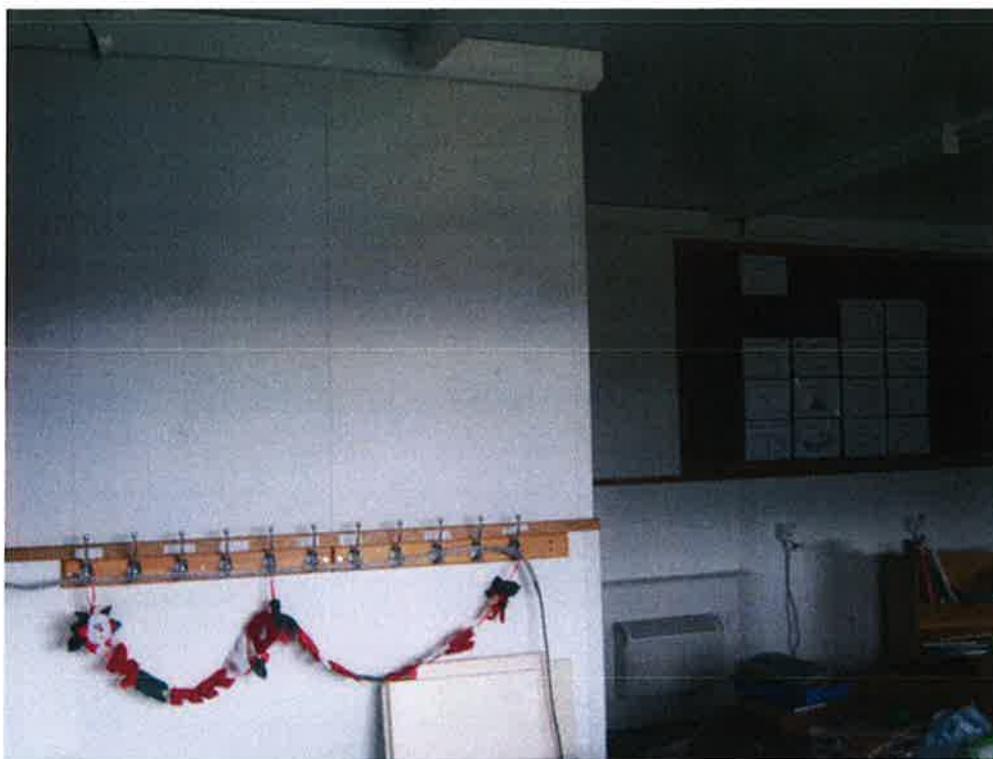
Sample No:	Sample 19-CS8991E/19	Picture 39
Survey Date:	12 <sup>th</sup> September 2012	
Location:	Youth centre	
Position:	Internal walls	
Component:	Textured coating	
Condition/ Protection:	-	
Accessibility:	-	
Analysis result:	<b>No asbestos detected</b>	
Risk Code:	-	
Recommended Action:	None

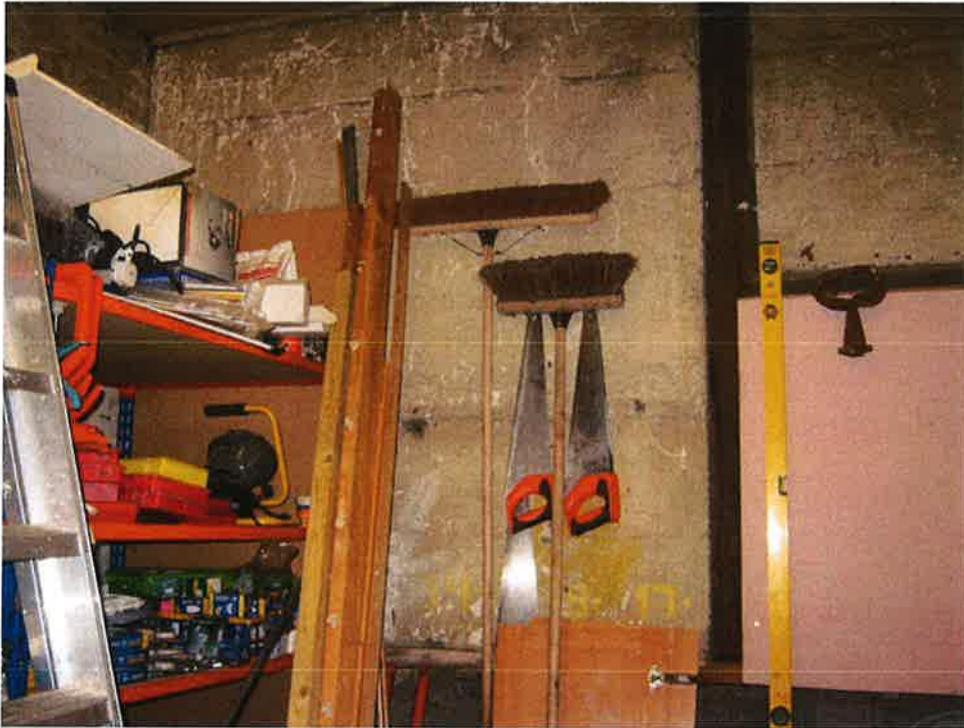
Sample No:	No sample	Picture 40
Survey Date:	12 <sup>th</sup> September 2012	
Location:	Garage	
Position:	Solid walls/plaster board ceiling	
Component:	-	
Condition/ Protection:	-	
Accessibility:	-	
Analysis result:	-	
Risk Code:	-	
Recommended Action:	No asbestos materials suspected

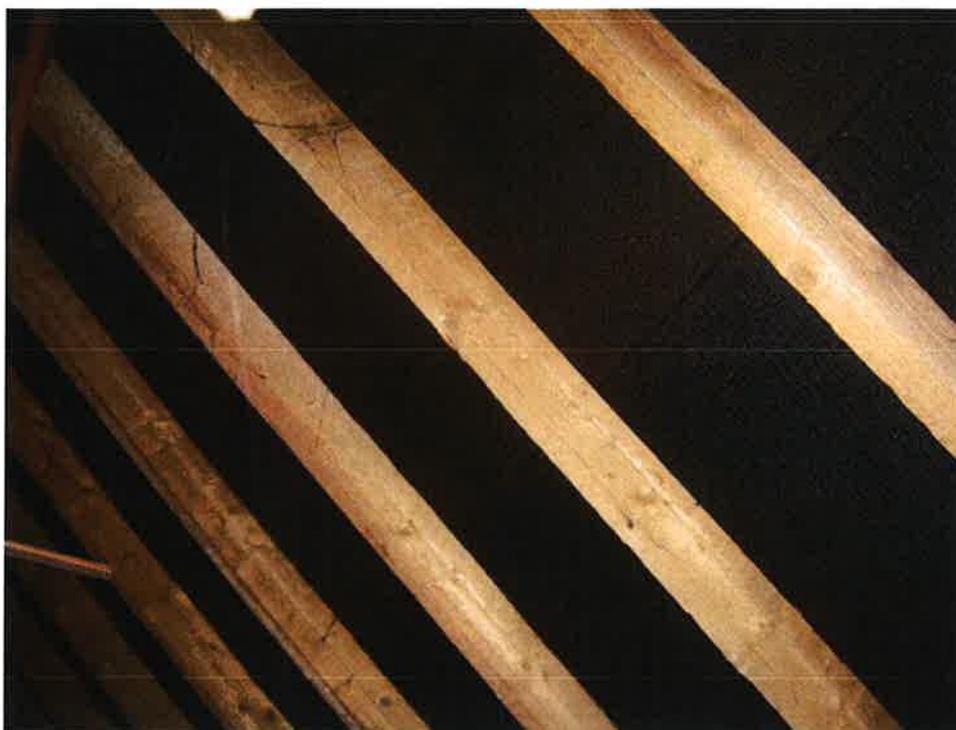
Sample No:	Sample 20-CS8991E/20	Picture 41
Survey Date:	12 <sup>th</sup> September 2012	
Location:	House	
Position:	Roof void	
Component:	Bitumen sarking felt	
Condition/ Protection:	-	
Accessibility:	-	
Analysis result:	<b>No asbestos detected</b>	
Risk Code:	-	
Recommended Action:	None

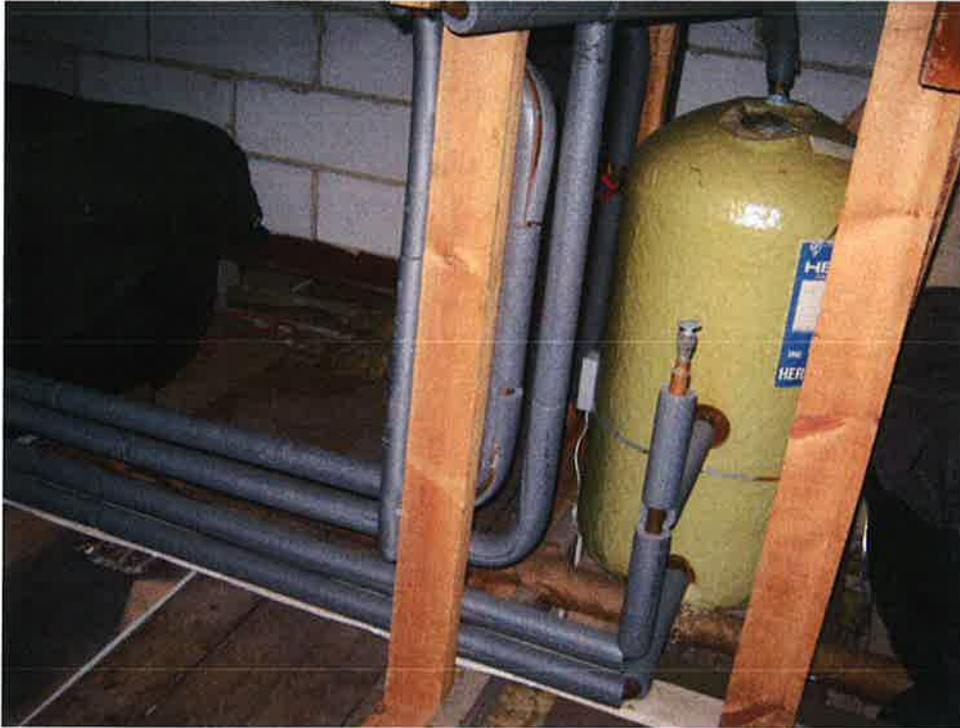
Sample No:	No sample	Picture 42
Survey Date:	12 <sup>th</sup> September 2012	
Location:	House	
Position:	Roof void	
Component:	Foam pipe insulation	
Condition/ Protection:	-	
Accessibility:	-	
Analysis result:	-	
Risk Code:	-	
Recommended Action:	No asbestos materials suspected

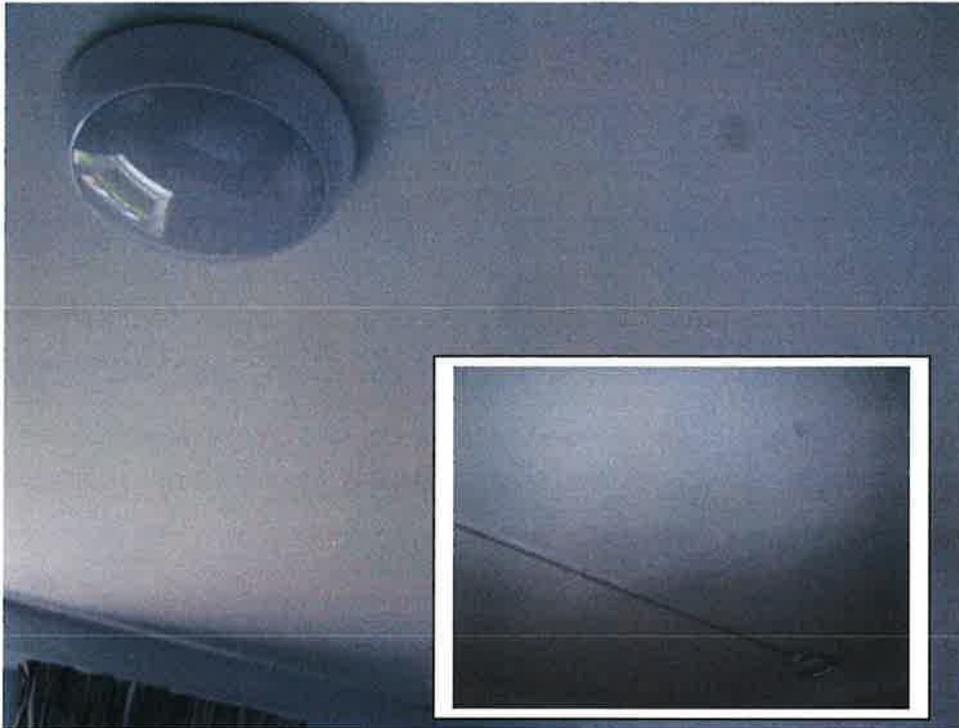
Sample No:	No sample	Picture 43
Survey Date:	12 <sup>th</sup> September 2012	
Location:	House	
Position:	Ceilings throughout	
Component:	Plaster board panels	
Condition/ Protection:	-	
Accessibility:	-	
Analysis result:	-	
Risk Code:	-	
Recommended Action:	No asbestos materials suspected

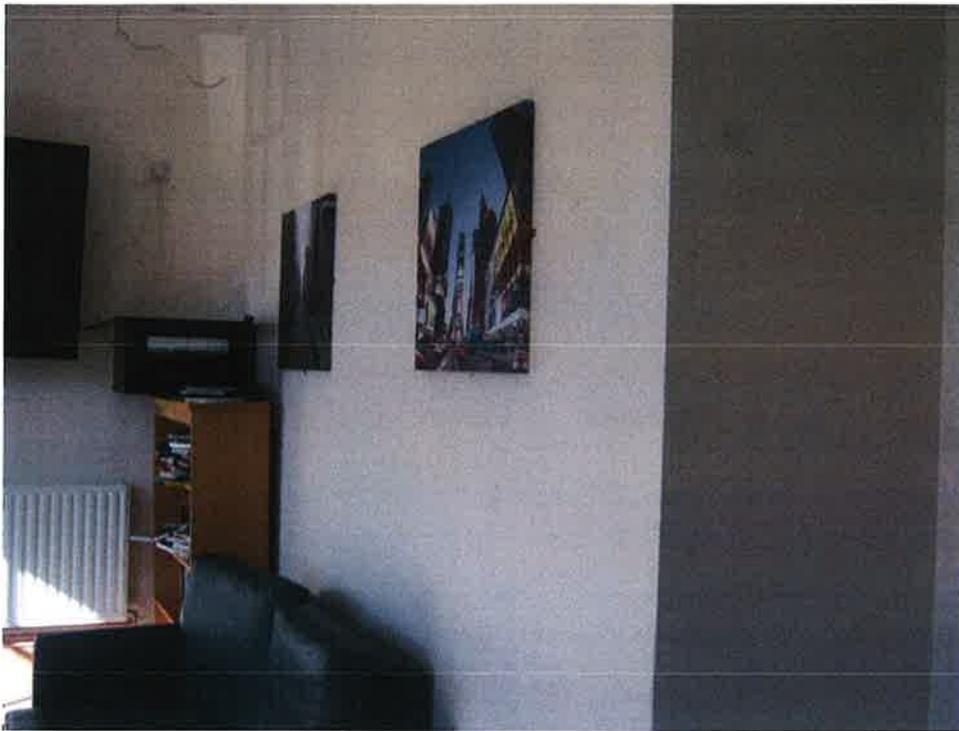
Sample No:	No sample	Picture 44
Survey Date:	12 <sup>th</sup> September 2012	
Location:	House	
Position:	Walls	
Component:	Solid and plaster rendered	
Condition/ Protection:	-	
Accessibility:	-	
Analysis result:	-	
Risk Code:	-	
Recommended Action:	No asbestos materials suspected

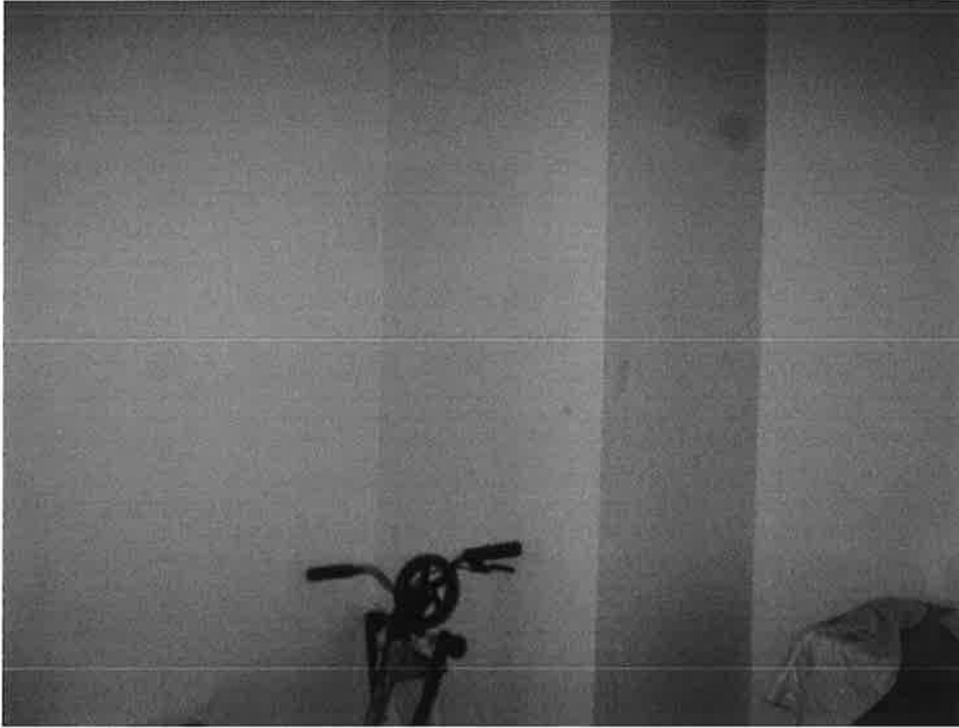
Sample No:	No sample	Picture 45
Survey Date:	12 <sup>th</sup> September 2012	
Location:	House	
Position:	Service cladding	
Component:	Plaster board/timber panels	
Condition/ Protection:	-	
Accessibility:	-	
Analysis result:	-	
Risk Code:	-	
Recommended Action:	No asbestos materials suspected

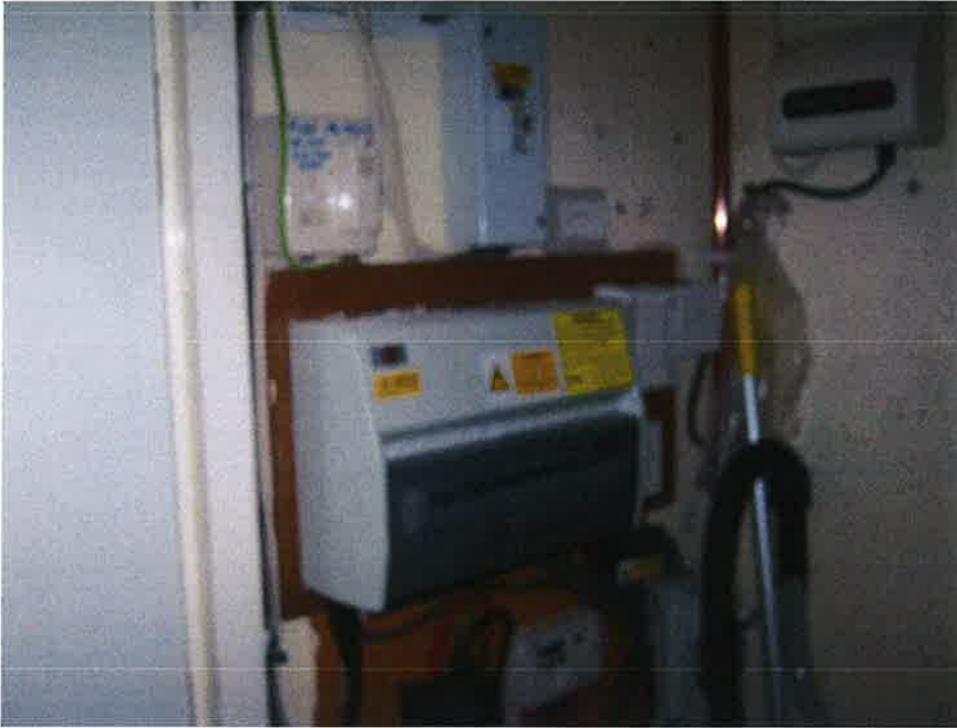
Sample No:	No sample	Picture 46
Survey Date:	12 <sup>th</sup> September 2012	
Location:	House	
Position:	Electrical intake	
Component:	Modern switch gear/fuse board	
Condition/ Protection:	-	
Accessibility:	-	
Analysis result:	-	
Risk Code:	-	
Recommended Action:	No asbestos materials suspected

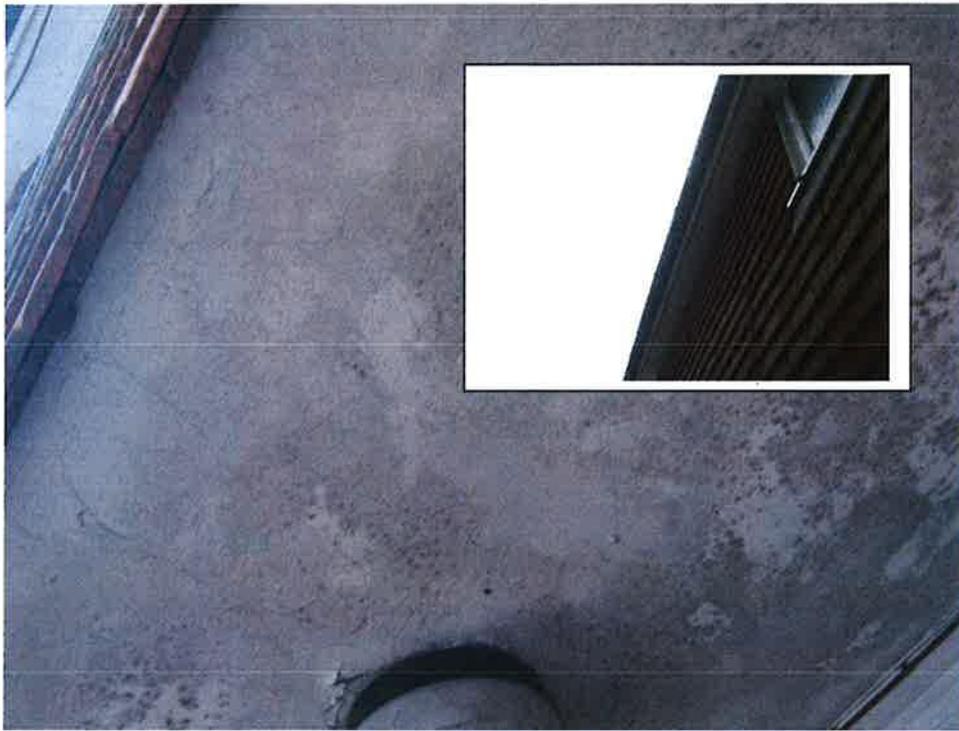
Sample No:	Sample 21-CS8991E/21	Picture 47
Survey Date:	12 <sup>th</sup> September 2012	
Location:	House	
Position:	External soffits	
Component:	Boarding	
Condition/ Protection:	Good/paint sealed	
Accessibility:	High	
Analysis result:	<b>Amosite (Brown) and Chrysotile (White) Asbestos</b>	
Risk Code:	C	
Recommended Action:	Work on this material requires a license. Work on this material is notifiable to the appropriate enforcing authority. Disposal of asbestos waste by a licensed contractor only. All work must conform to the 'Control of Asbestos Regulations 2012'.
